Virginia Department of Mines, Minerals & Energy
Division of Mines

Accident Investigation Report
Underground Coal Mine

Electrocution Fatality
January 21, 2003

Dorchester Enterprises, Inc.
Mine No. 4
Mine Index No. 14698AA
Wise County, Virginia

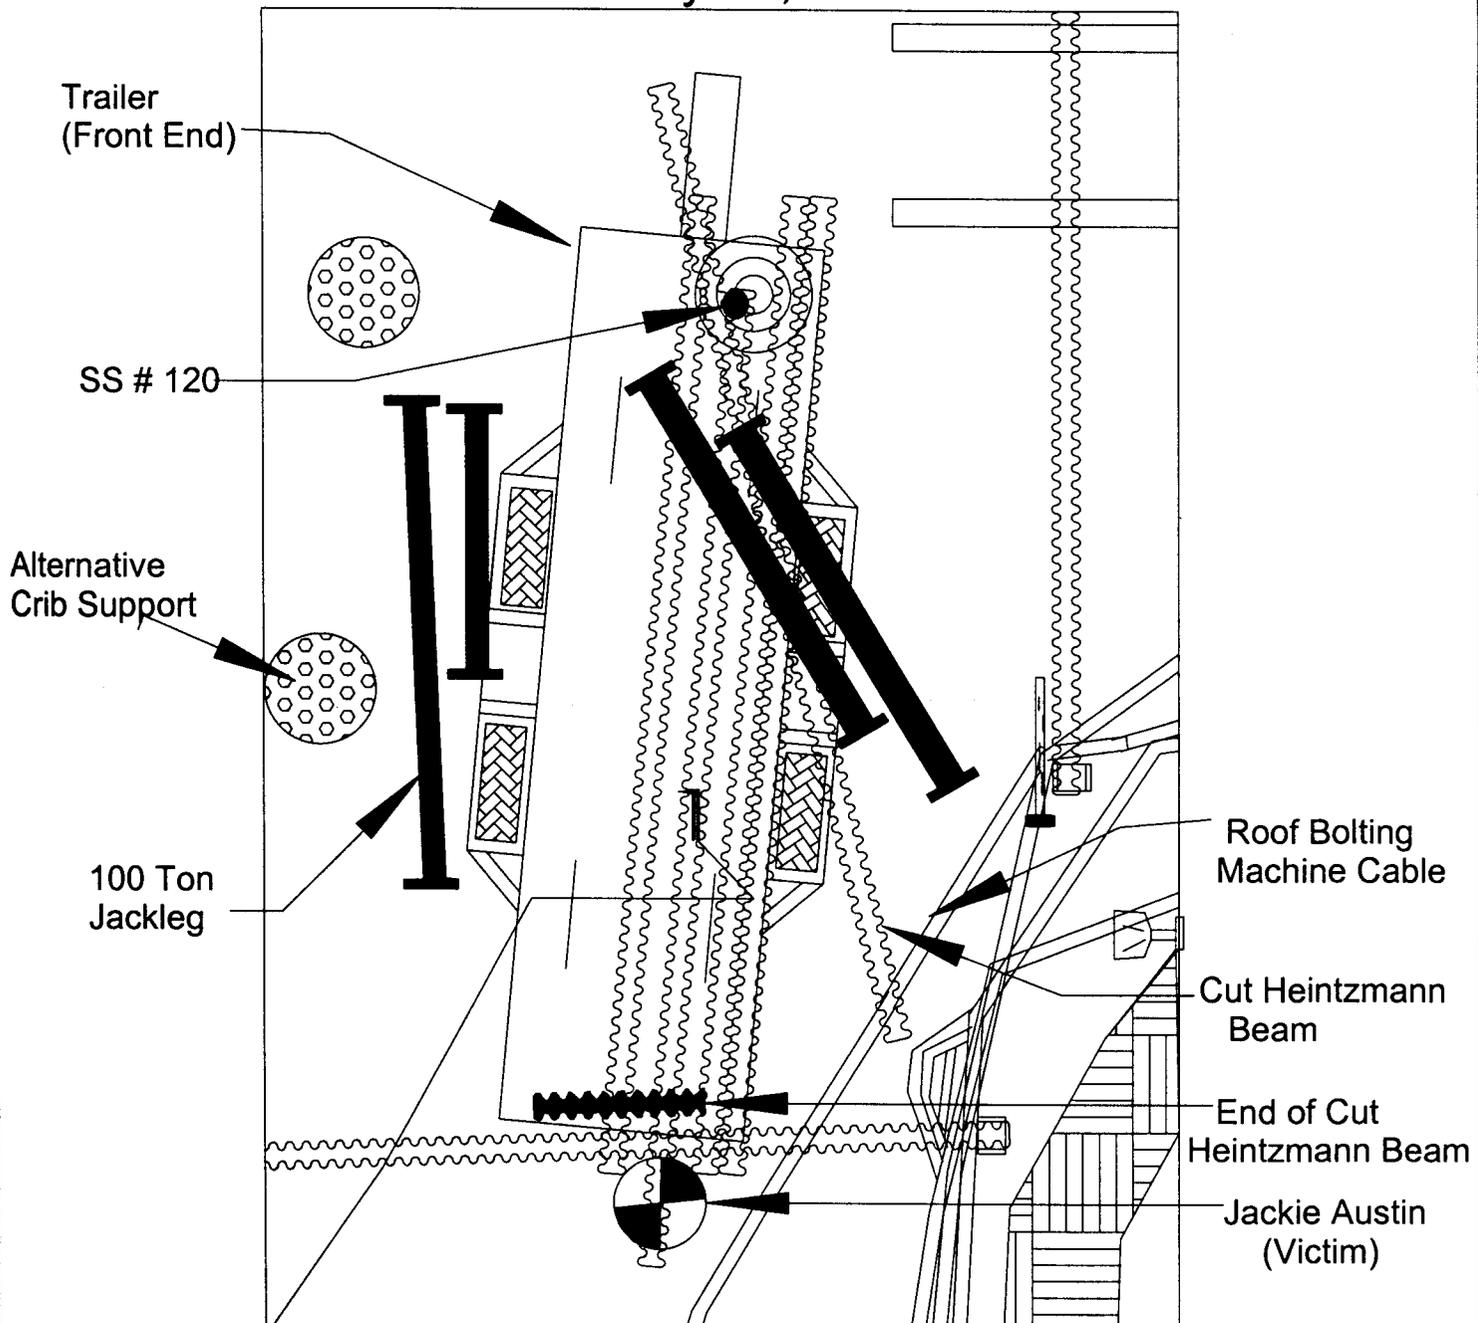
FATAL ACCIDENT SCENE
Dorchester Enterprises, Inc.
Mine No. 4
Mine Index No. 14698AA
January 21, 2003

7. The beam that had been cut was observed lying partially on the trailer with the cut end lying against the mine floor in close proximity to but not touching the 480 volt, three phase, alternating current, No. 1 roof bolting machine trailing cable that was energized when the accident occurred. The cut end of the beam had a jagged edge with protruding slag that resulted from the cutting process. This cut end of the beam had been hot when placed on the mine floor in the immediate vicinity where the energized No. 1 roof bolting machine trailing cable was located.

10. A damaged place on the energized 480-volt, No. 1 roof bolting machine trailing cable was observed in close proximity to but not touching the end of the beam that had been cut. The outer insulation of the trailing cable had been ruptured and physical damage had exposed the red phase conductor inside the cable. The damaged place on the cable was the most likely source of electricity that could have energized the metal trailer and beams.
