Virginia Minerals

NOVEMBER 2005

A PRELIMINARY INVESTIGATION OF THE CHIMBORAZO HILL LANDSLIDE OF AUGUST 30, 2004

Mark W. Carter and C. R. Berquist

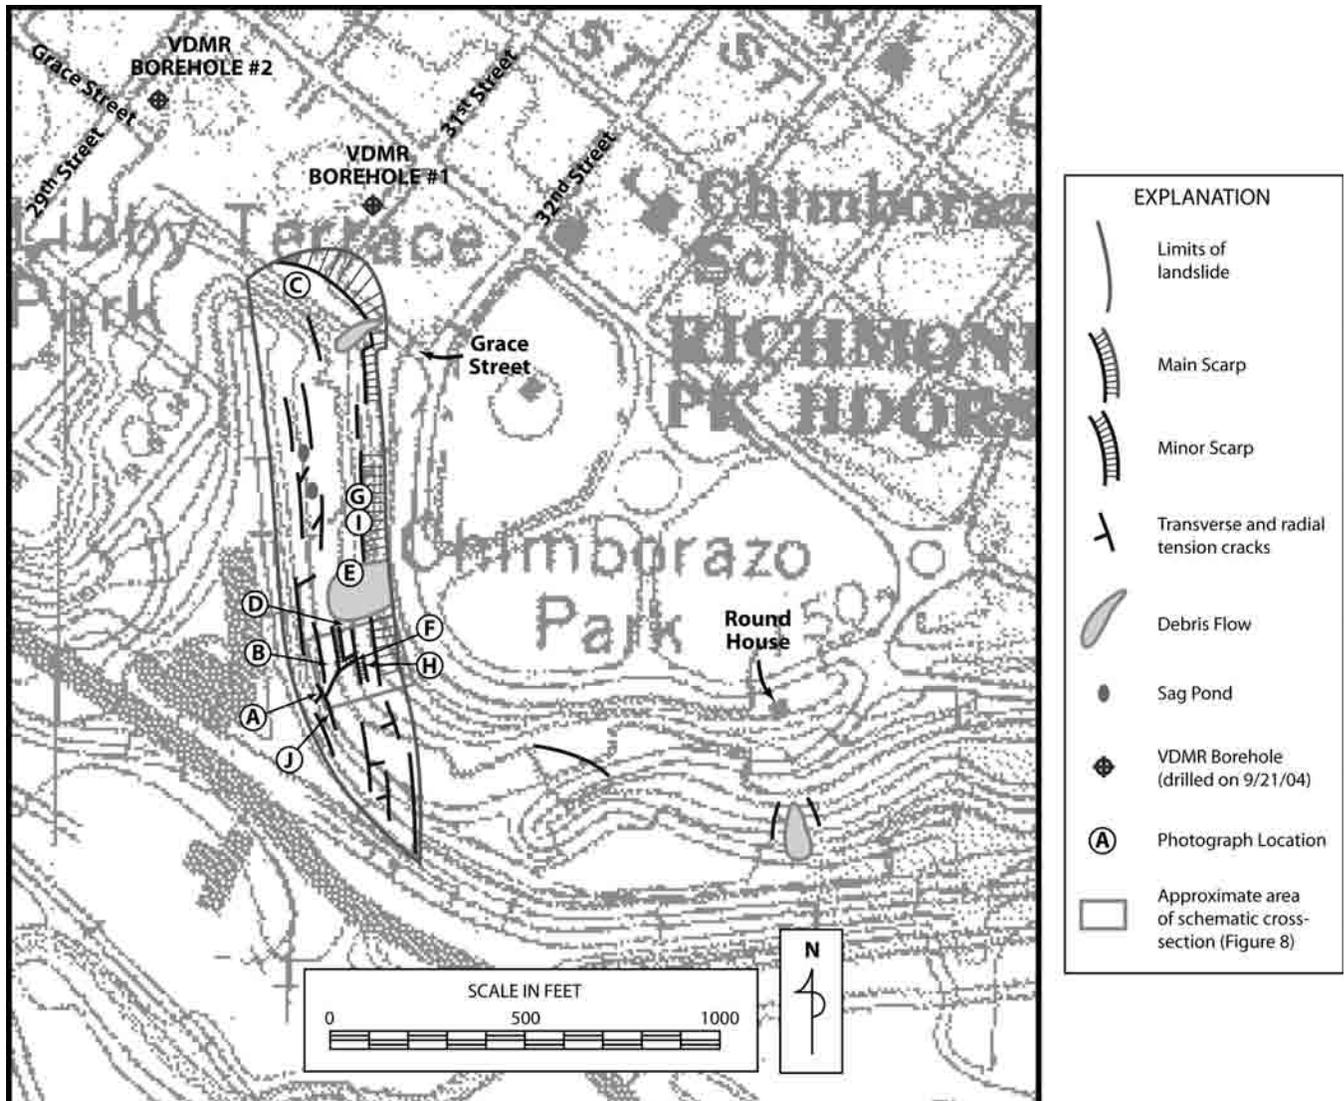
The Chimborazo Hill landslide covers approximately 11 acres on the west-facing slope of Chimborazo Hill (Figure 2). It extends from the southeastern corner of the Chimborazo Park playground at 31st and Grace streets southward to the Norfolk Southern Railroad tracks south of Chimborazo Hill and from the crest of Chimborazo Hill westward to the abandoned railroad grade in the stream valley of lower Blood Run.

Figure 2: Preliminary reconnaissance map of the Chimborazo Park landslide. Basemap from digital rastergraphic image of the 1994 USGS Richmond 7.5-minute topographic map. Key to photograph locations in figures: Locations A, B, D, J - Figure 5; location C - Figure 3; location E - Figure 7; locations F, H - Figure 6; locations G, I - Figure 4. The abandoned railroad line west of Chimborazo Park occupies the stream valley of lower Blood Run. Upper Blood Run has been partially filled; it originated to the northeast, approximately between 31st and 32nd streets.

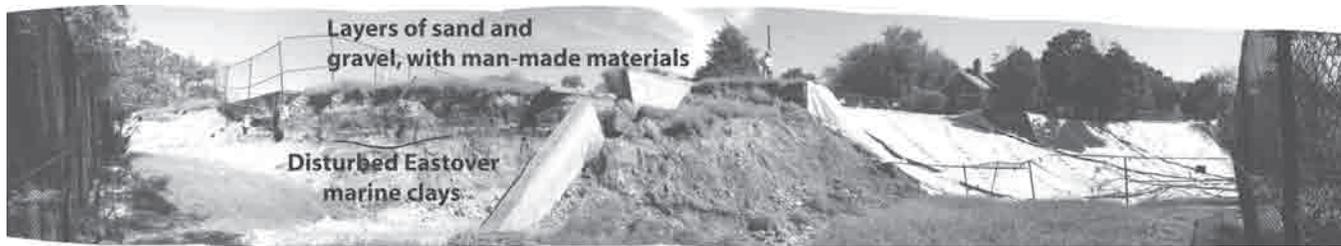
scarp exposes fill material (Figure 3), but from the southeastern corner of the playground portion of the slide southward to its terminus on the upper side-slope of Chimborazo Hill, the scarp exposes fresh outcrops of the Yorktown/Bacons Castle and Eastover Formations¹ (Figure 4).

Figure 3. Panoramic photograph, panning from the north (left side) to east (right side) of the Chimborazo Park playground portion of the landslide, taken on September 21, 2004. Photograph is from location “C” in Figure 2. Notice the successive layers of fill in the main scarp on the left side of the photograph. “Natural ground” crops out along the scarp in the trees behind the fence on the far right side of the photograph.

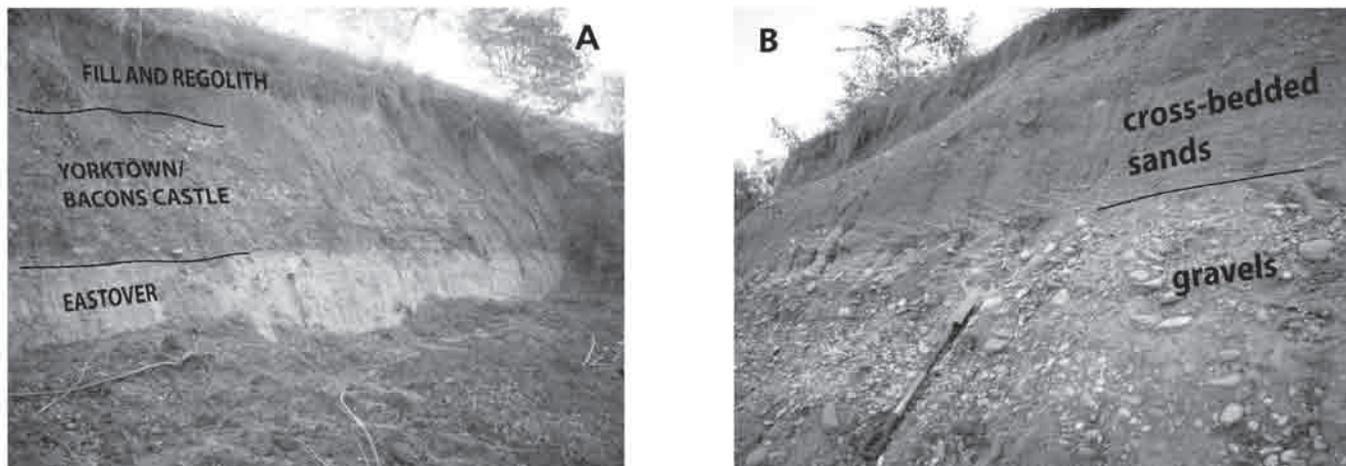
Figure 4. Photographs of the main scarp on the west slope of Chimborazo Hill. A: Photograph, looking southeast, of the fresh exposures of Yorktown/Bacons Castle Formations (sand and gravel layers) above Eastover marine clays in the main scarp. Photograph is from location “G” in Figure 2. Shovel is approximately 3.5 feet long. B: Photograph, looking northeast, of the fresh exposures of Yorktown/Bacons Castle Formations (cross-bedded sand and gravel layers) in the main scarp. Eastover Formation crops out just below shovel handle. Photograph is from location “I” in Figure 2.

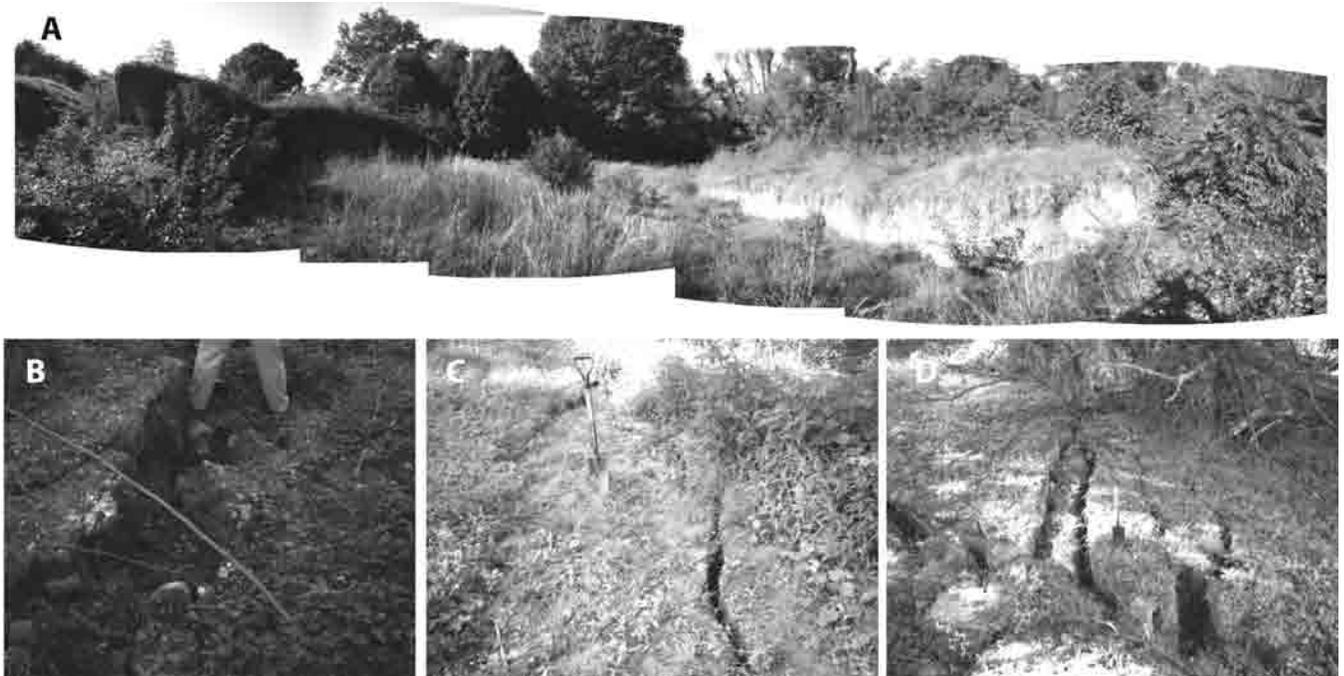
Figure 5. Photographs of tension cracks and minor scarps on the west slope of Chimborazo Hill. A: Panoramic photograph, panning from the south (left side) to west (right side) showing minor scarps. The main scarp is just out of view on the far left side of the photograph. Notice the large block (that stands nearly 8 feet higher than the adjoining one), the graben in the middle of the photograph, and the higher elevated block on the right side. Weathering on the face of the minor scarp on the right side of the photograph suggests that the tension crack it utilized (a preexisting fracture or joint in the Eastover?) was open and exposed to weather for some time prior to the August 30 movement (this could also be an indicator of pre-Gaston slope instability). Photograph is from location “D” in Figure 2. B: Photograph, looking north, of a tension crack at location “J” in Figure 2. This tension crack appears to have channelized water after formation as it is partially filled with alluvium. C: Photograph, looking north, of a downthrown block between two north-south trending tension cracks at location “B” in Figure 2. Shovel is approximately 3.5 feet long. The block on the far right of the photograph is on the downslope (western) “toe” of the landslide but is actually higher in elevation than the two eastern blocks closer to the main scarp. None of the blocks here show a reversed slope back toward the main scarp. D: Photograph, looking southwest, of transverse and radial tension cracks in the body of the landslide at location “A” in Figure 2. This photograph serves as a model for the structure of the larger landslide.

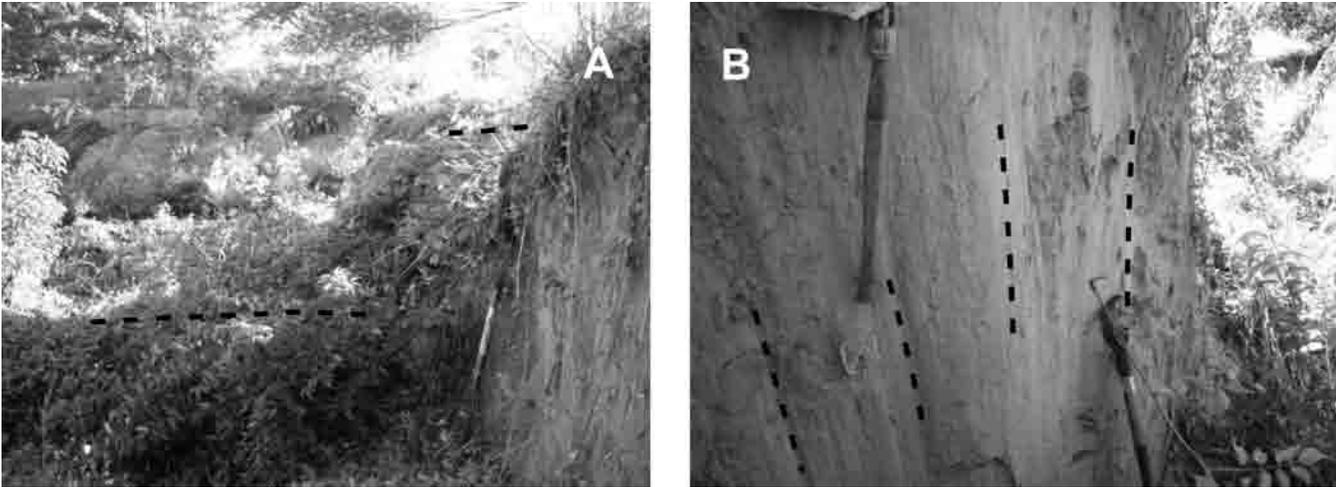
Figure 6. Photographs of minor scarps on the west slope of Chimborazo Hill. A: Photograph, looking east, along a minor radial scarp at location “F” in Figure 2. Notice that the displacement along the retaining wall (top of the wall is highlighted with a dashed line) is mostly vertical, with little translational movement toward the camera. A portion of the main scarp near its terminus is visible in the background. This is the same block that is visible on the left side of the panoramic photograph “A” in Figure 5. Shovel is approximately 3.5 feet long. B: Photograph, looking west, of the face of a minor transverse scarp at location “H” in Figure 2. The face, exposing marine sandy clay of the Eastover Formation, is very fresh and the relatively soft material has preserved slickenlines (highlighted with dashed lines) on the scarp face. Had this face been exposed to weathering prior to the storm on August 30th, the slickenlines would not have been preserved. This photograph was taken on the transverse scarp face behind the retaining wall in Figure 6A.

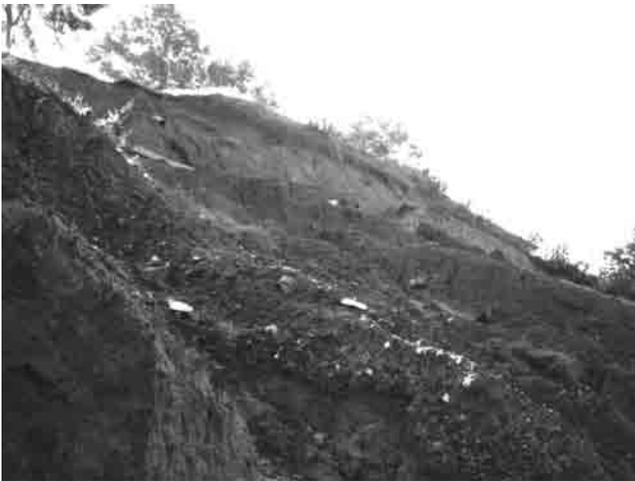
Two smaller-scale debris flows (at 31st and Grace streets, and on the western slope of Chimborazo Hill), composed mostly of unconsolidated fill material and sands and gravels of the Yorktown/Bacon's Castle Formations, started within and modified the main scarp, most likely after failure of the much larger slide (Figures 2 and 7). Debris from the flows appears to fill

Figure 7. Photograph, looking southeast, of the debris flow at Chimborazo Hill at location “E” in Figure 2. A portion of the main scarp is visible in the upper part of the photograph below the crest of the hill.

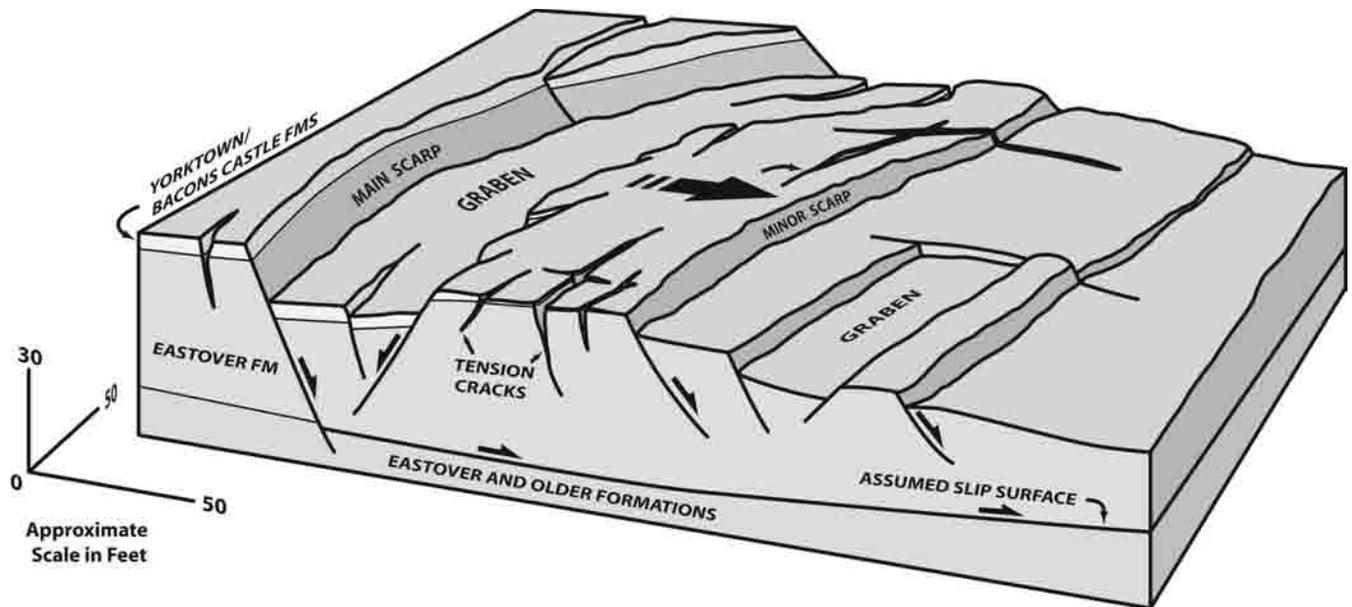
The Chimborazo Hill landslide is classified as a compound earth-debris slide, having components of both rotational and translational sliding (Cruden and

Varnes, 1996) (Figure 8). Translational sliding appears dominant in the southern part of the Chimborazo Hill landslide, whereas rotational sliding appears to be the dominant failure movement in the vicinity of the Chimborazo Park portion of the slide.

Figure 8. Tentative schematic cross-sectional model of the internal geometry of the Chimborazo Hill landslide (modified from Varnes, 1978). Elements and nomenclature of landslide features are labeled, including the main scarp, minor scarps, underlying rupture surface, and transverse (parallel to main scarp) and radial (perpendicular to main scarp) tension cracks. Smaller arrows show vertical and horizontal displacements of internal blocks, whereas the overall translational displacement in the down slope direction is shown by the large arrow in the middle of the diagram. Rotational movement, in which the landslide toe “kicks out” to allow the mass above to slump down behind it (with slope reversals back toward the main scarp on the slumped blocks), is not portrayed in the diagram.

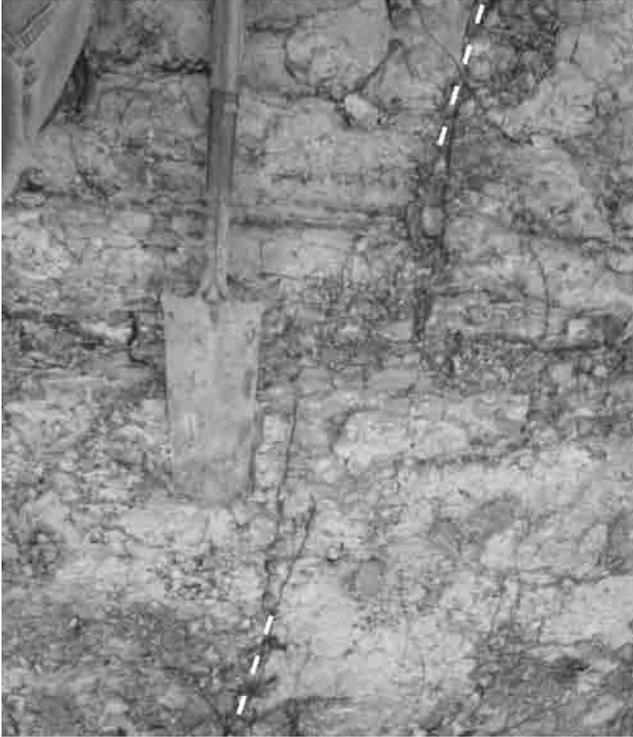
During the September 17 visit to the Richmond area landslides, the authors observed and recorded numerous fractures, or joint sets in the clays of the Eastover Formation and overlying Coastal Plain units (Figure 9). Joint spacing ranged from 1 to 3 feet. A preliminary analysis of the data suggests two regional trends – N50°-70°W and N5°-15°E (Figure 10). The main scarp of the Chimborazo Hill landslide, south of the playground, appears to have developed along the N5°-15°E set. Many of the tension cracks and minor scarps within the body of the slide also appear to roughly parallel these trends. At present, data are too sparse to draw firm conclusions, so the role that pre-existing discontinuities (fractures) in the undisturbed Coastal Plain sediments played in the development of the landslide is suspected but still unclear.

Figure 9. Photograph of regional fracturing (jointing) in marine clays of the Eastover Formation in a fresh exposure below the Monte Maria Academy at 21st and East Grace streets in downtown Richmond. The joint (highlighted by a dashed line) trends N52°W into the hill slope and dips 84° to the northeast. Spacing within the joint set is 2 to 3 feet. Horizontal fractures, stained brown from the reduction of pyrite in the clay, parallel primary sedimentary bedding.

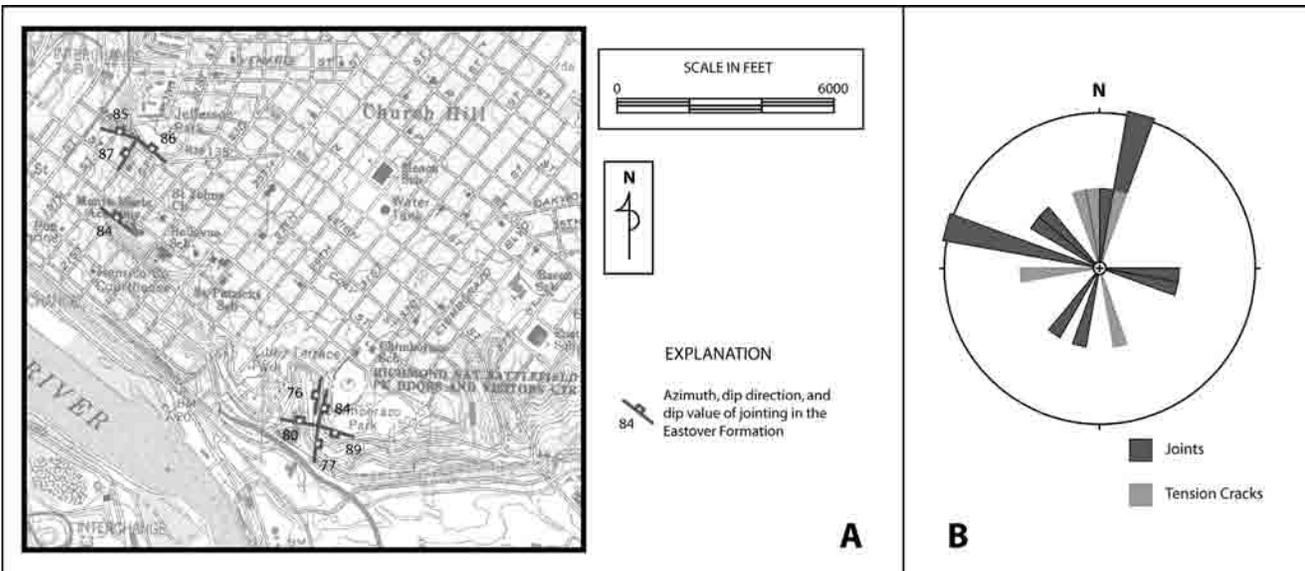
Figure 10. Reconnaissance map of regional joint trends and stereographic projection of joint and tension crack data. A: Reconnaissance map of regional joint trends. Joints were observed and measured at Jefferson Park, Monte Maria Academy, and the Chimborazo Hill landslide. Basemap from digital rastergraphic image of the 1994 USGS Richmond 7.5-minute topographic map. B: Unidirectional rose diagram of joint and tension crack orientations. Tension crack orientations were measured in the body of the Chimborazo Hill landslide.

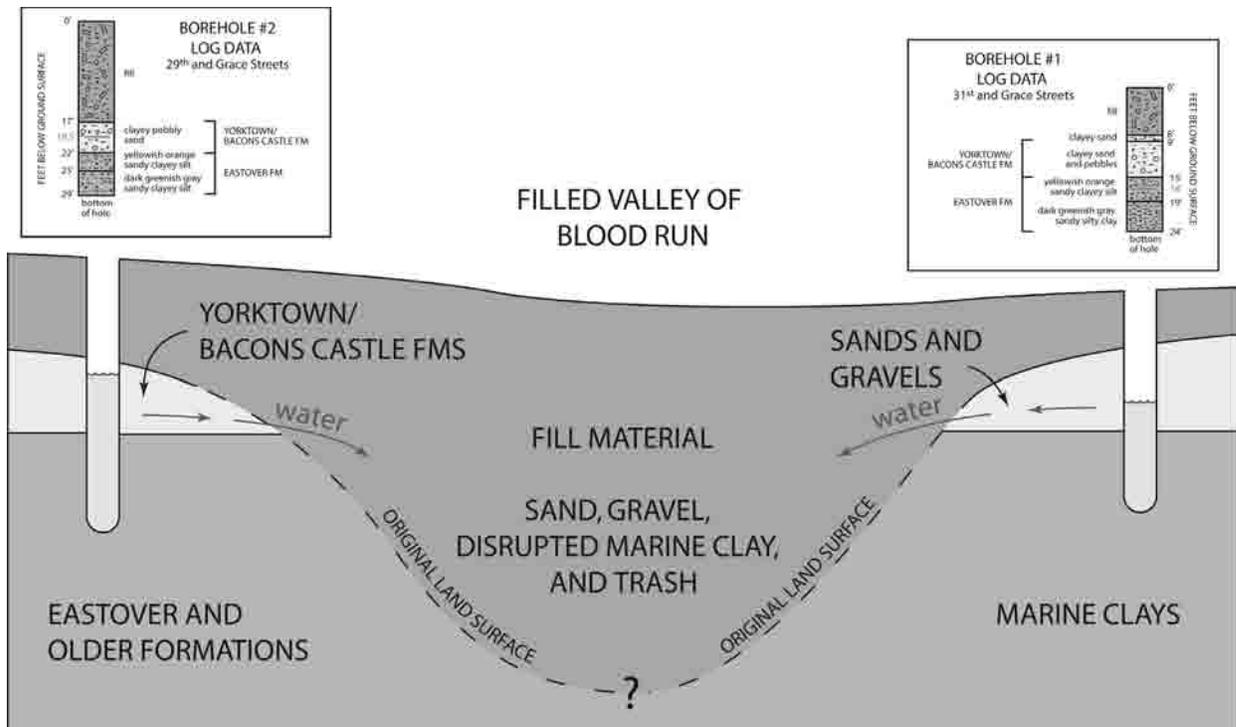
Figure 11. Schematic cross-section along Grace Street (from 29th to 31st streets) showing the original land surface, fill material in the valley of Blood Run, and interpreted geologic conditions at the playground. Ground water has probably been draining into the fill material for many years, which contributed to the instability of foundations, buried storm and sewer pipes, and the landslide failure of August 30, 2004.
