Virginia Department of Mines, Minerals & Energy
Division of Mines

Fall of Roof Material
Fatality Investigation Report
July 25, 2008

Consolidation Coal Company
Buchanan Mine No. 1
Mine Index No. 11912AA
Buchanan County, Virginia

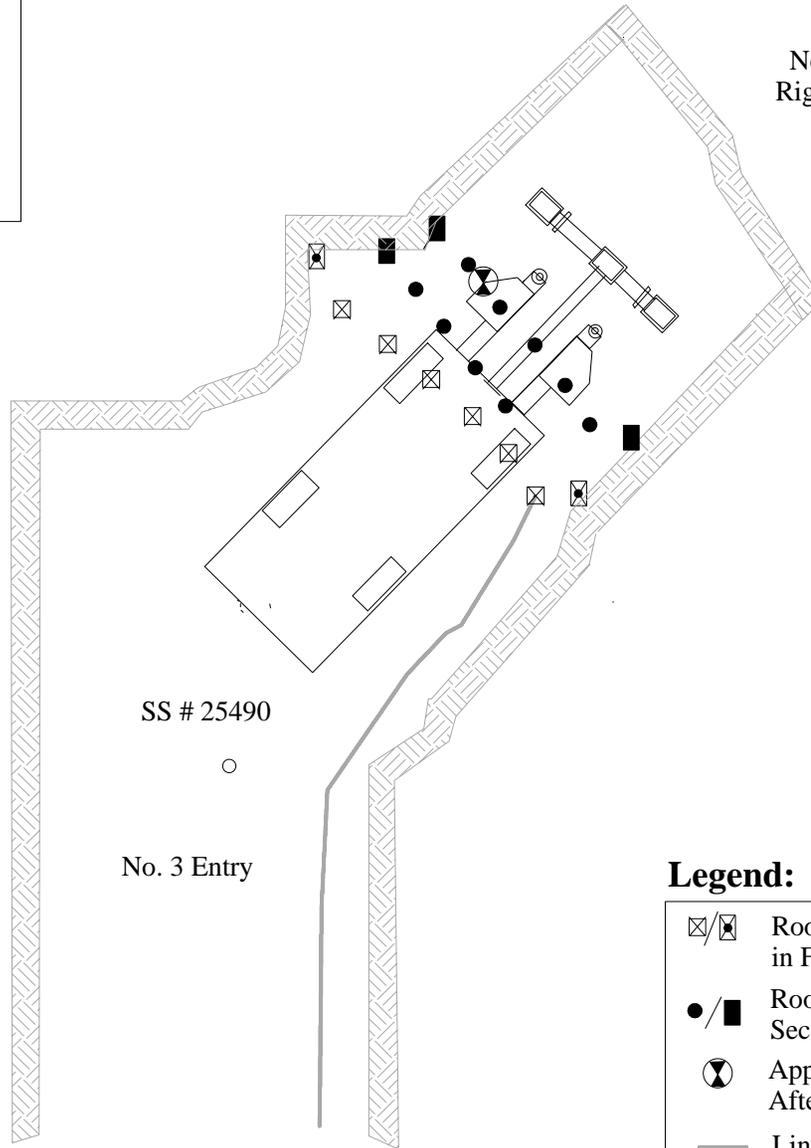
No. 3 Entry
Right Crosscut

- ☒/☒ Roof and Rib Bolts Installed in First Miner Cut
- /■ Roof and Rib Bolts Installed in Second Miner Cut
- ⊗ Approximate Location of " Victim " After Accident
- Line Curtain

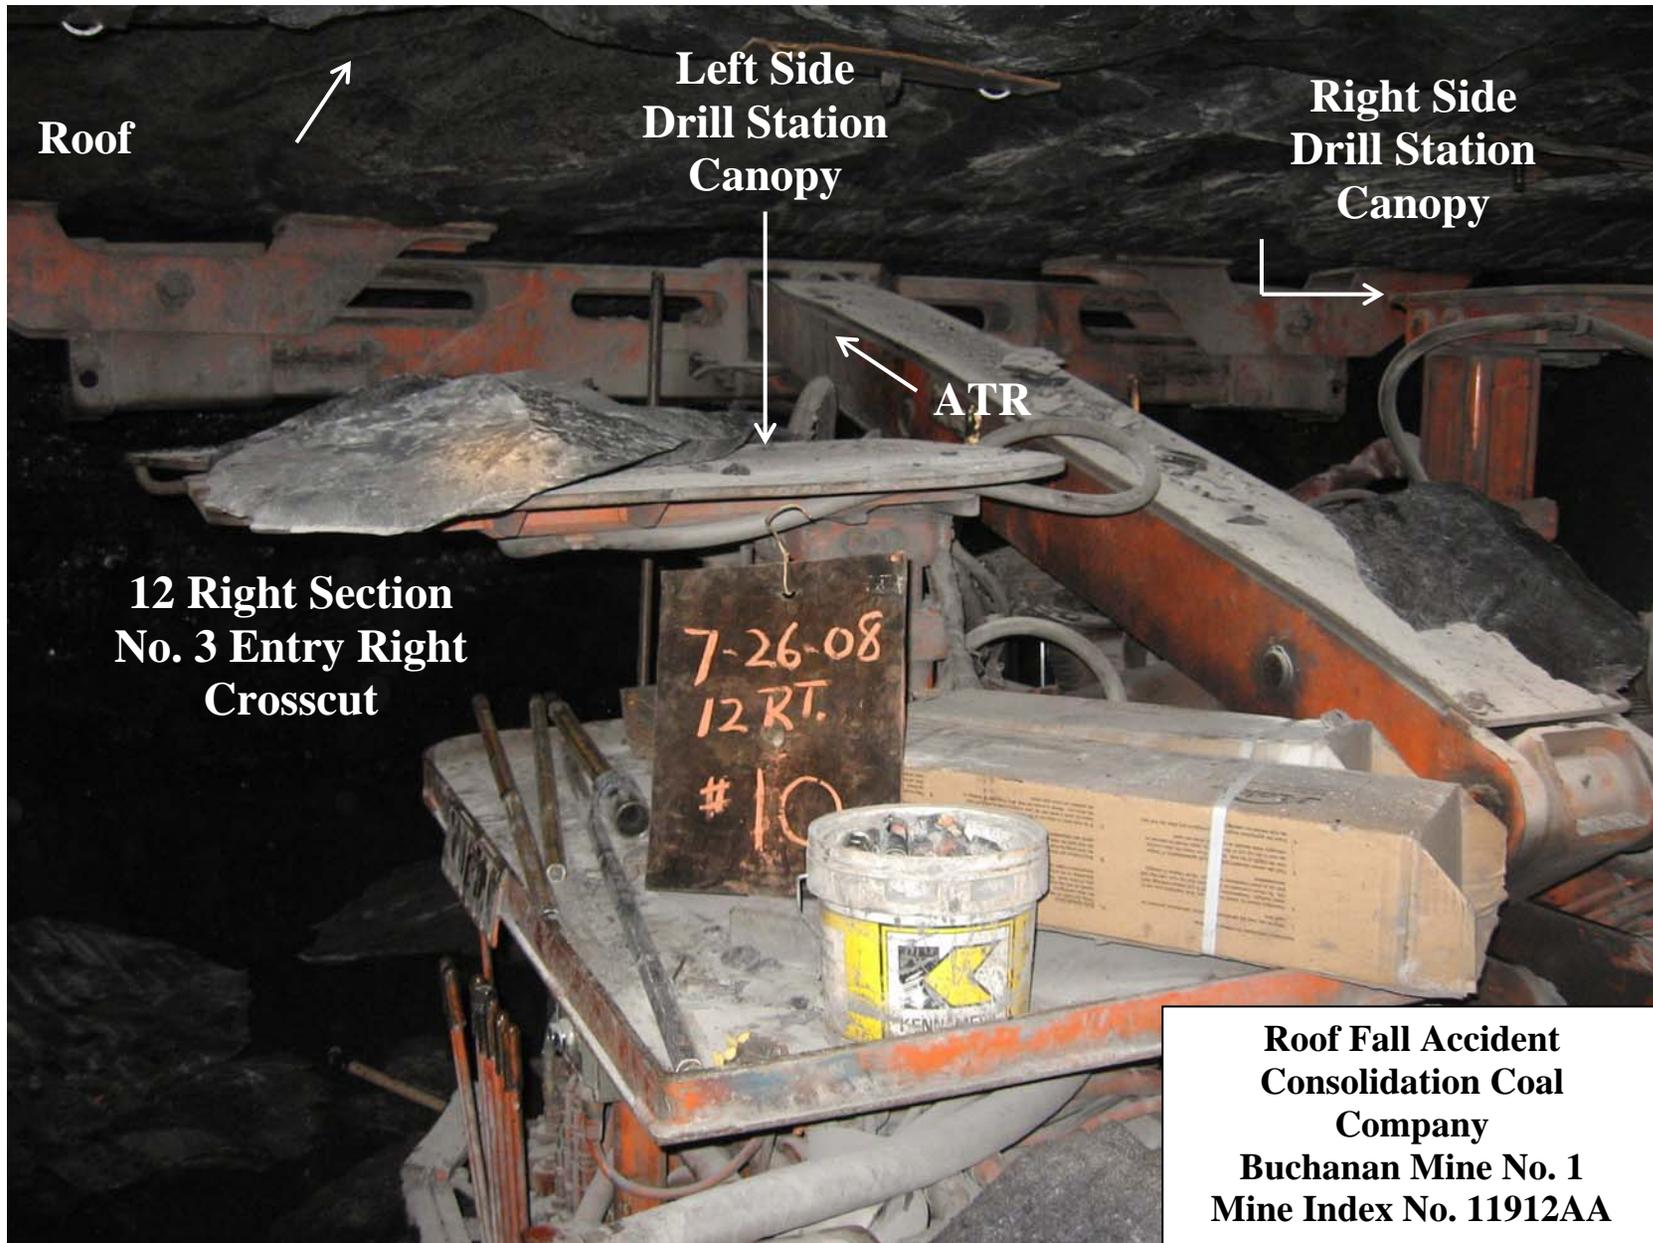
**12 Right Section
No. 3 Entry Right
Crosscut**

**Smaller Rocks
on Drill Station
Canopy**

**Drill Canopy
Extension**

**Two Sections
of Fallen Roof**

**Approximate
Location
of Victim At Time
of Accident**

9. The two sections of roof that fell from the mine roof between the ATRS and left side, drill canopy of the roof bolting machine were located on the mine floor. One section of rock that fell had a chalk mark on its surface which was apparently placed on the roof by Todd with a marking stick that he was using to mark the placement location of roof bolts to be installed in the third row, in the No. 3 entry right crosscut. This section of rock that fell was located approximately 25 inches from the front edge of the left drill canopy and measured approximately 37 and ½ inches in width, 49 inches in length and nine inches in thickness. The left coal rib adjacent to this section of fallen rock also had a chalk mark on the rib indicating the rib bolt placement location.

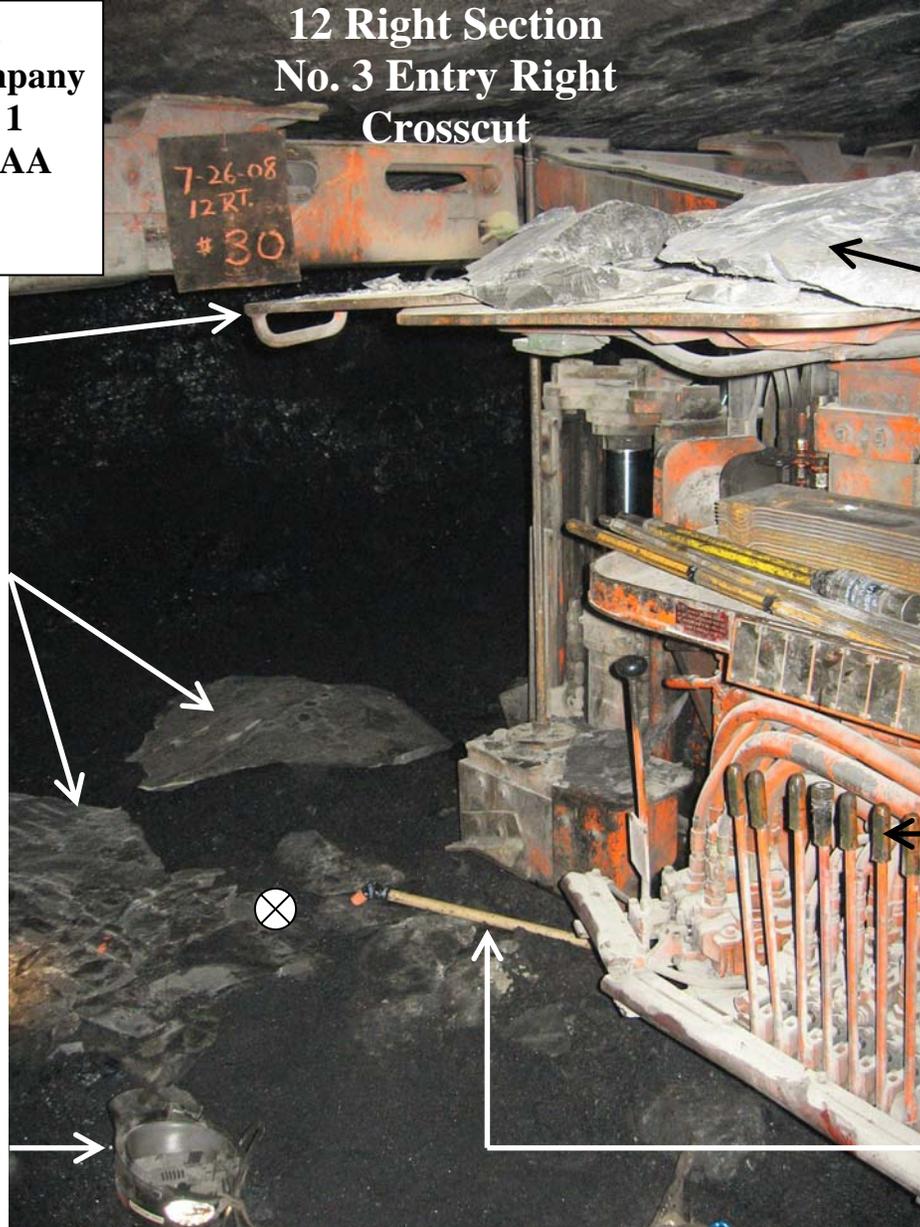
Victim's Hard Hat

21. Mr. Rasnake and other mine personnel stated that Todd was unconscious at the scene of the accident and while being transported to the surface.
22. The hard hat that was worn by Todd at the time of the accident was a low profile style hard hat. The hard hat was lying on the mine floor near the left rib, inby the left side, operator drill controls. The hard hat was damaged from the impact of the fallen roof and the damages included scuff marks / scratches on the left side of the hard hat, a vertical fracture line on the left side, front part of the hard hat exterior, measuring approximately four (4) inches in length and a broken hat brim, on the left side, front part of the hard hat. The mining belt, battery light and the self-contained self-rescuer device (SCSR) being worn by Todd were also observed lying on the mine floor near the left side, drill station.

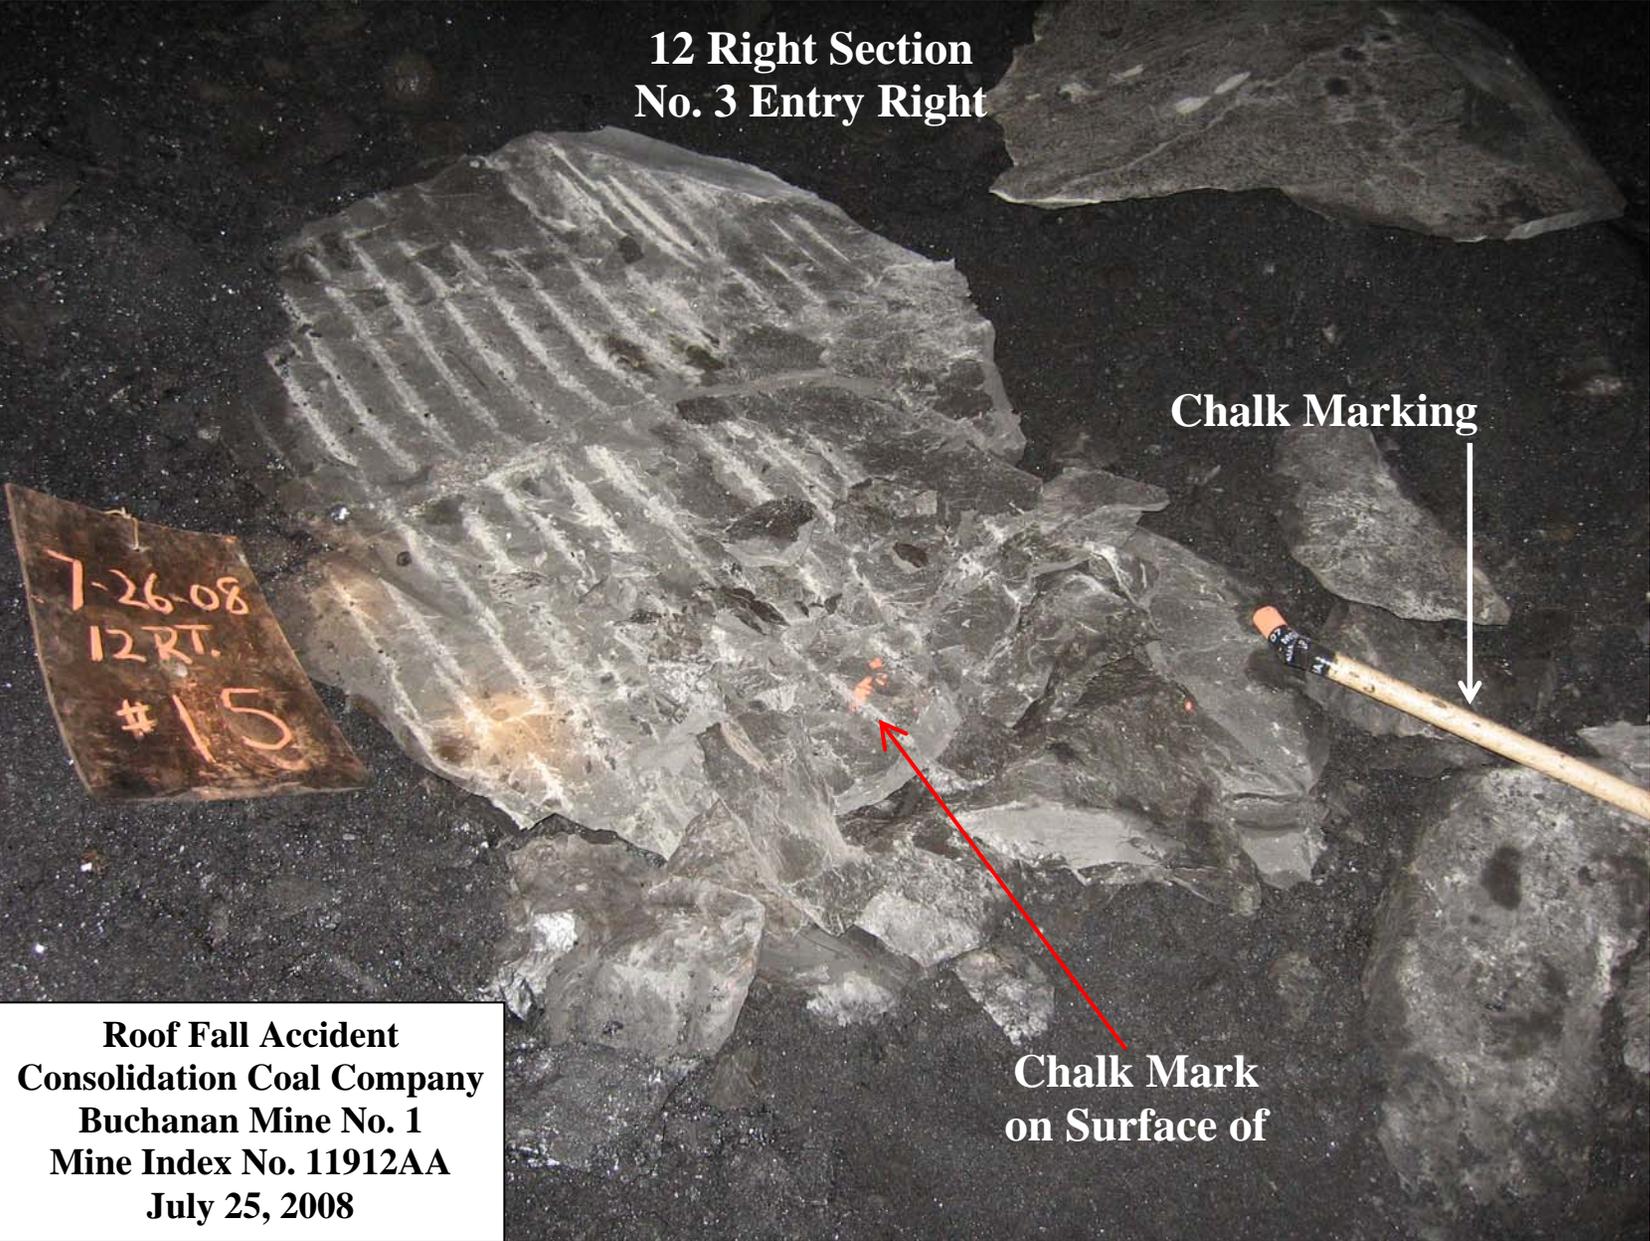
**12 Right Section
No. 3 Entry Right**

Chalk Marking

**Chalk Mark
on Surface of**
