Division of Mineral Mining

Fatal Accident: Over-the-Road Truck Owner/Operator February 2, 2007

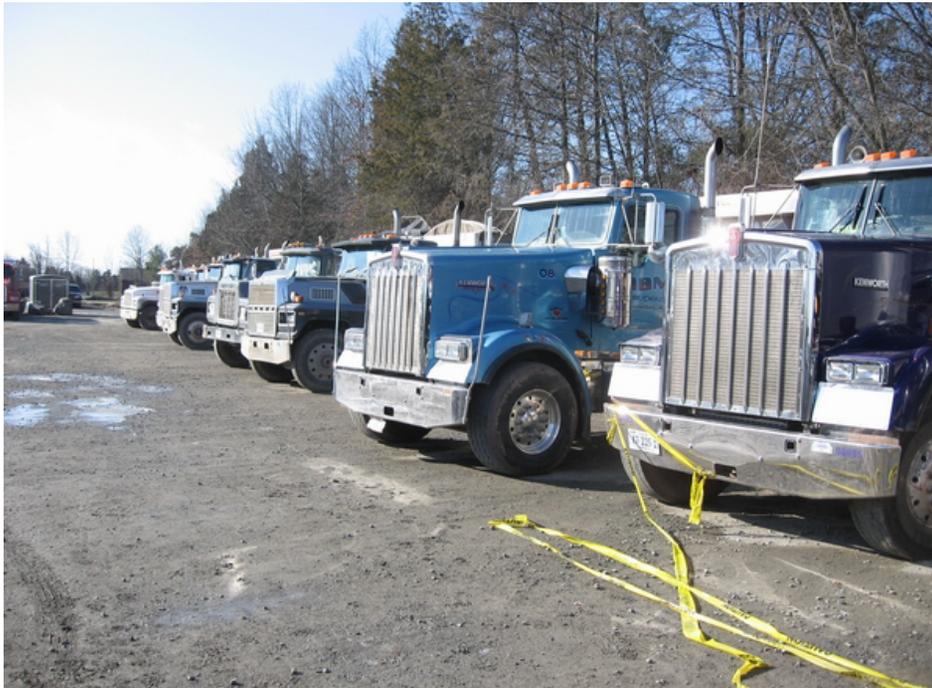
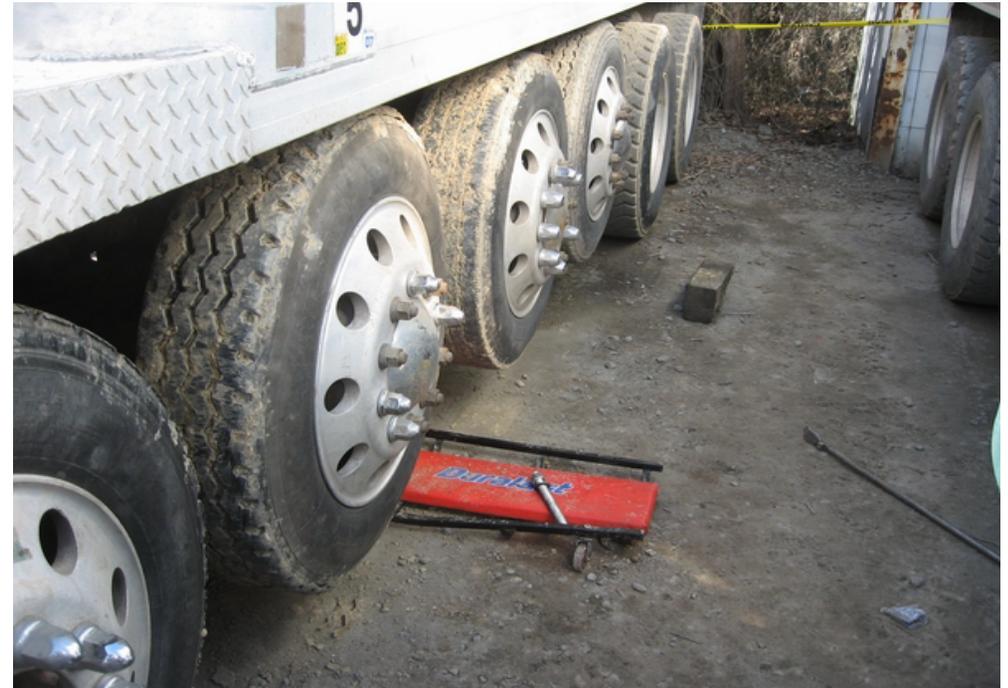
A trucking contractor was fatally injured Friday, February 2, 2007, at a quarry in Virginia. The 38-year-old victim was the owner/operator of a small fleet of tandem trucks that operated out of the quarry. He was fatally injured while performing repairs to a pony axle assembly on one of his trucks. Preliminary findings indicate that a small hydraulic jack supporting one of the tires slipped allowing the axle assembly to drop onto his chest and abdomen. The victim had eight years of experience as an independent contractor.

RECOMMENDATIONS: To prevent a similar accident from occurring, always properly block equipment against hazardous motion prior to starting repairs as required by Virginia Safety and Health Regulations for Mineral Mining 4 VAC 25-40-1685. The Division of Mineral Mining recommends that operators and contractors periodically conduct job safety/risk analyses to identify potential safety hazards associated with all work tasks and to develop safe work procedures.
