Division of Mineral Mining

Accident Investigation: Machinery Accident April 23, 2002

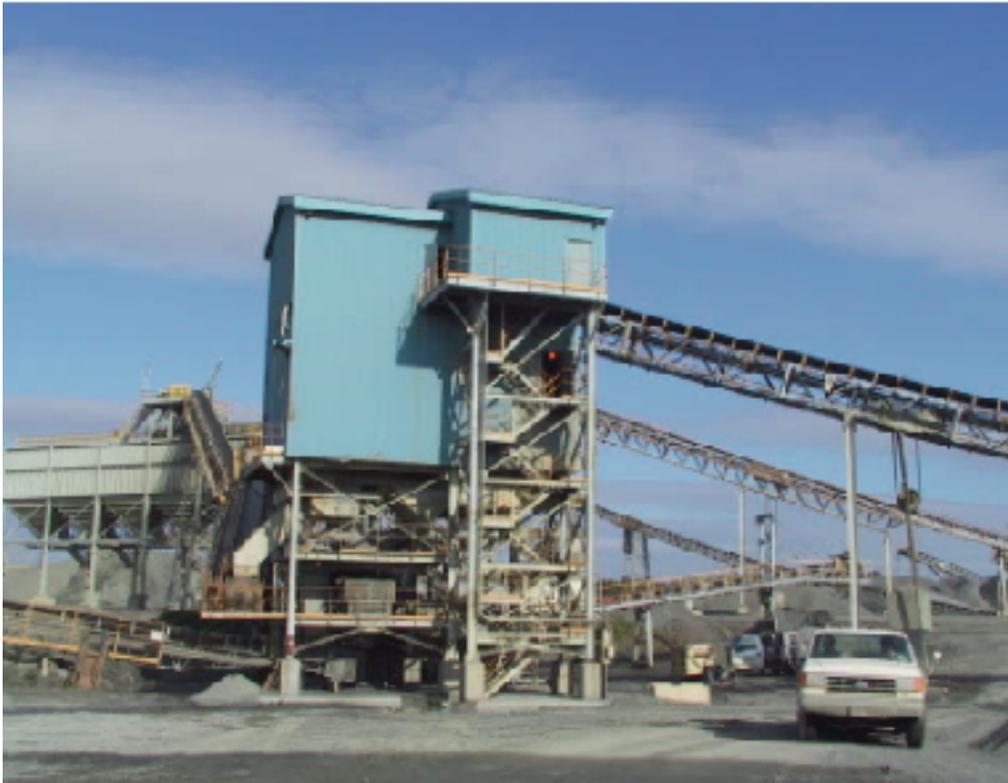
A maintenance repairman was injured when a Deister screen flywheel counterweight (200-lbs) fell from the chain hoist that was in use at the time and mashed his left middle finger against an I-beam structure. Medical treatment at a local hospital included the removal of the end of his injured finger at the first joint.

Deister screen located in wash tower in processing plant of quarry.

RECOMMENDATIONS: Always inspect hoists prior to use each shift to ensure safe operating condition and to ensure that the load or counterweight is securely attached. In addition, employees should be aware of the location of suspended loads and avoid standing or working beneath suspended loads.

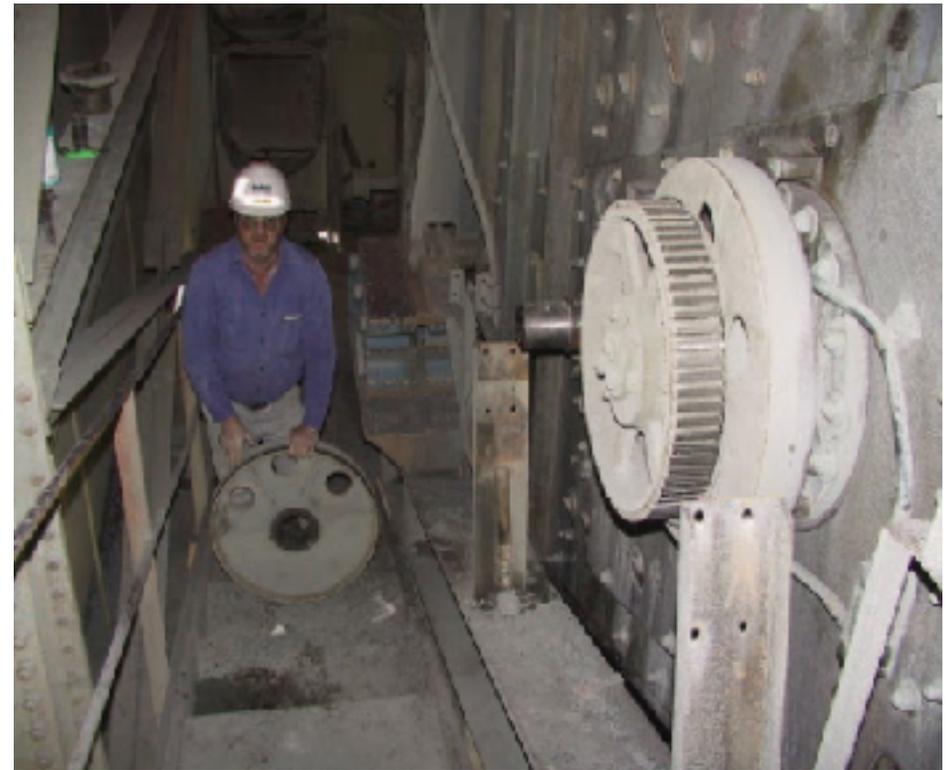
Mine foreman displaying the screen flywheel counterweight.
