DMM Safety Alert:

Mechanic/Driller Fatally Injured

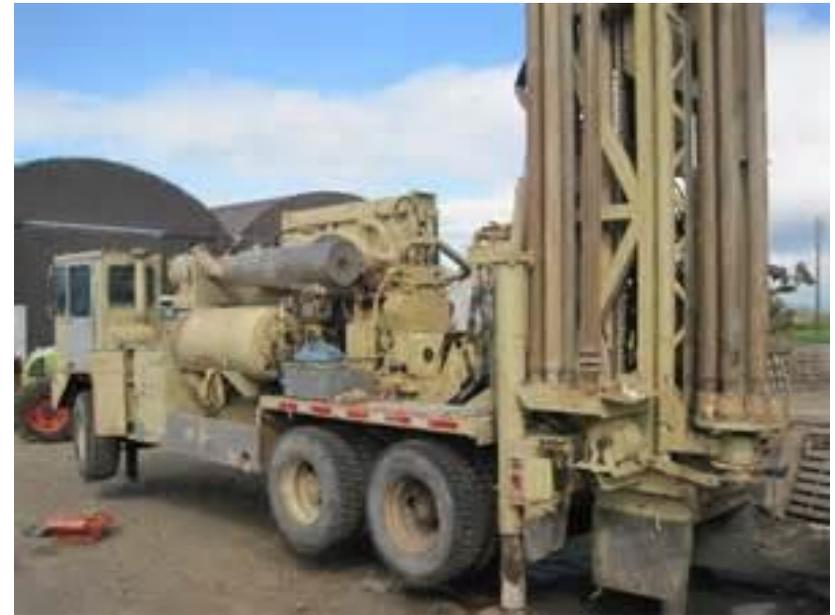
On September 21, 2016, a 52-year-old contractor mechanic/driller with 27 years of mining experience was fatally injured. The miner was using a pipe wrench to loosen a nut on the rotary head of an Ingersoll Rand T4BH drill. He was standing on the deck operating the drill controls from outside the cab when the pipe wrench struck him in the abdomen causing severe injuries. The miner tried to climb off the drill rig using a step ladder, but fell and struck his head. Other mine personnel saw the miner fall and called 911 after determining the severity of his injuries. Local EMS personnel transported the injured miner to a local hospital and he was later air-lifted to another hospital for surgery. The victim died during surgery as a result of blunt force trauma caused by the pipe wrench.

A drill similar to the one involved in this accident

- Mine operators and independent contractors should establish safe procedures for performing all types of work. All mine personnel and contractor personnel should be trained in proper procedures for the work assigned.
- Proper tools and procedures should be used when performing tasks.
- Equipment manufacturer recommendations should be followed when performing maintenance or repairs on equipment.
- When performing maintenance or repairs to equipment, make sure the power is off and the equipment is blocked against motion, except when motion is necessary to make adjustments.
