HAZARD ALERT TOMORROW

Gas Well - Near Miss

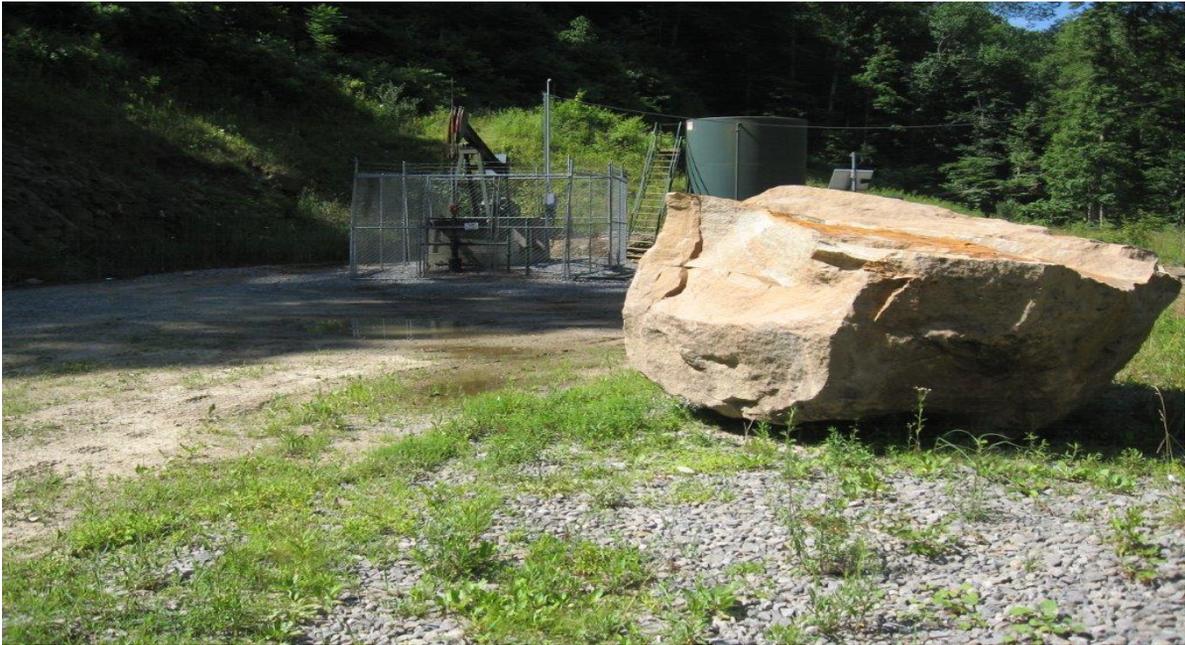
On June 28th, 2016 at approximately 3:30 p.m., DMME was notified that a large boulder dislodged from a surface mine located upslope and traveled an estimated 700 feet before striking a portion of a surface gas well installation. The rock was 9.5 ft. x 9 ft. wide and 4 ft. to 6 ft. high. No injuries were reported as a result of this incident.

- Mining methods must ensure adequate slope stability and provide effective control for dislodged material .
- Examine work areas to identify all possible hazards. Ensure that potential hazards are evaluated and eliminated so tasks can be performed safely.
- Regularly inspect the catch berms to ensure that they are not filled with spoil material. During rainfall events , more frequent examinations will be required.
- Ensure berms are properly constructed. Remember that berms are a safety barrier and should always be properly maintained.
- Regular safety meetings should be conducted with all employees regarding possible hazards that could result from dislodged material.
