SAFETY ALERT BULLETIN

ACCIDENT REDUCTION PROGRAM

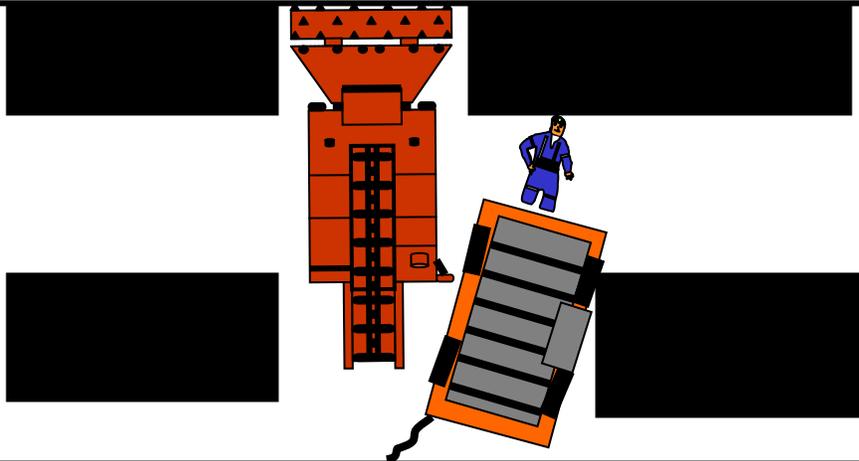
On August 8, 2005, at 9:30 p.m., a continuous miner operator was struck by a shuttle car. The shuttle car had just been loaded and began to travel up an incline when, for unknown reasons, it suddenly rolled backwards. The miner operator, with his back turned toward the shuttle car, was struck by the bumper of the car. The miner operator's left leg was fractured in two locations, one above the knee and one below the knee.

- Operators of mobile equipment shall face in the direction of travel when moving their equipment.
- When an emergency situation occurs, the machine panic bar should be activated to de-energize the motors to lock the brakes and stop the machine.
- Task training for operators of mobile equipment should always include operational and safety procedures to follow while operating on inclines.
- Mining personnel should always closely observe mobile equipment located in their work area to insure adequate clearance should an emergency situation arise, especially on or near inclines.
