Division of Mineral Mining

## Serious Injury Accident Investigation: Fall Accident March 11, 2002

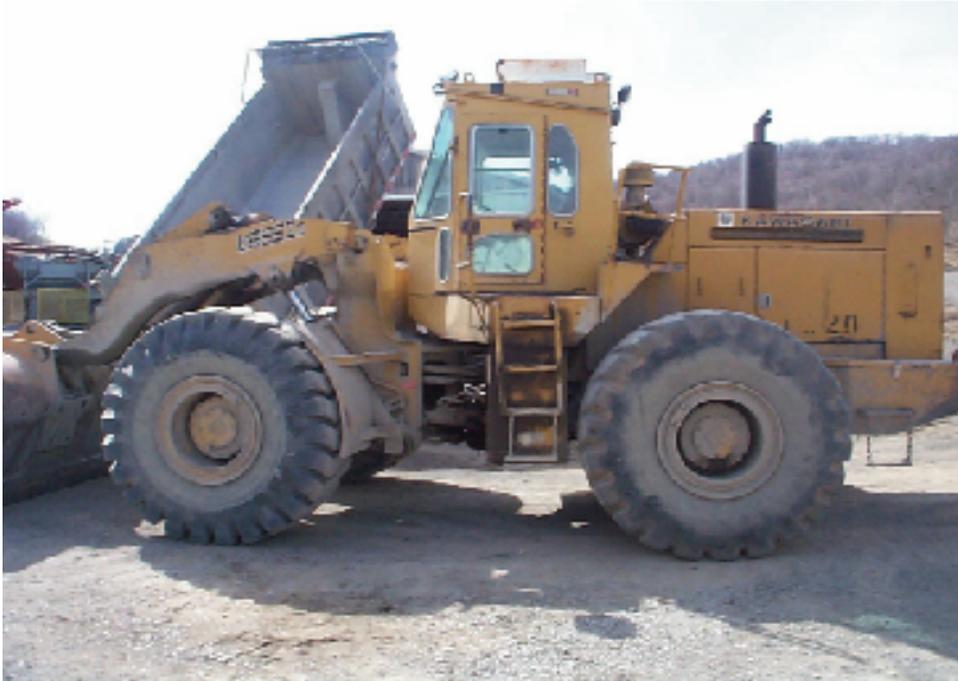
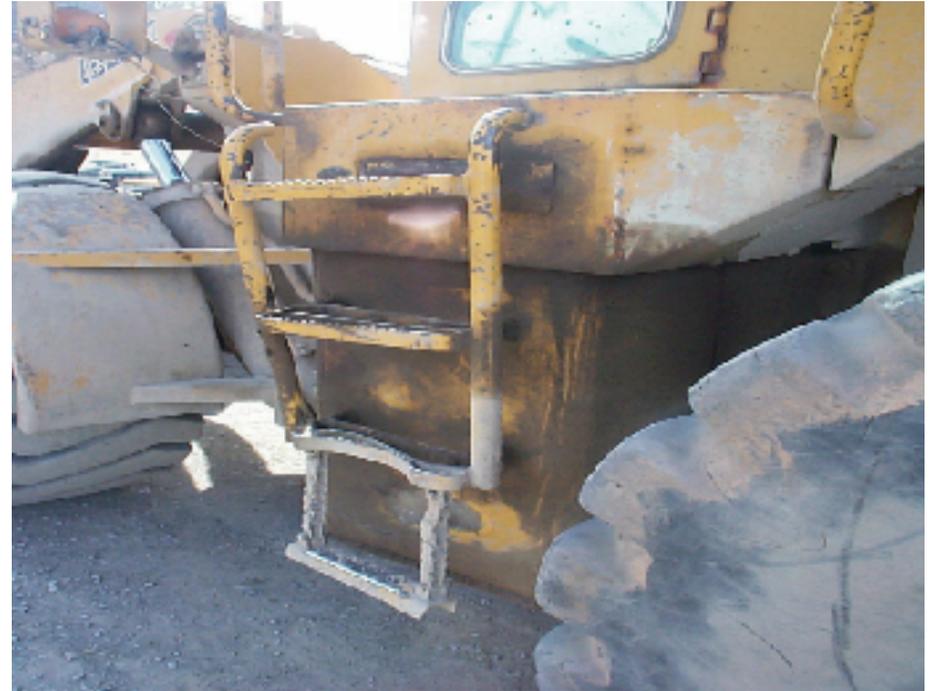
The operator of a Kawasaki 85-Z front-end loader broke his foot when he fell from the bottom step of the loader's access ladder. The operator was admitted to the hospital and required surgery to repair his broken foot. The access ladder on the operator's side of the loader was extensively bent, and the bottom flexible step was loose and improperly fastened at the time of the accident. In addition, the operator's boots were muddy and the soles were worn and contained little tread.

**RECOMMENDATIONS:** Falls from mobile equipment continue to account for a significant number of serious injury accidents at mineral mines in Virginia. Always inspect access ladders during the “pre-operational inspection” and throughout the day to ensure safe and functional condition. In addition, when climbing or descending ladders maintain 3 points of contact, and face the ladder and have both hands free for climbing as required by DMM safety regulation 4 VAC 25-40-1910.
