DMM Safety Alert:

Miner Fatally Injured In Silo Collapse

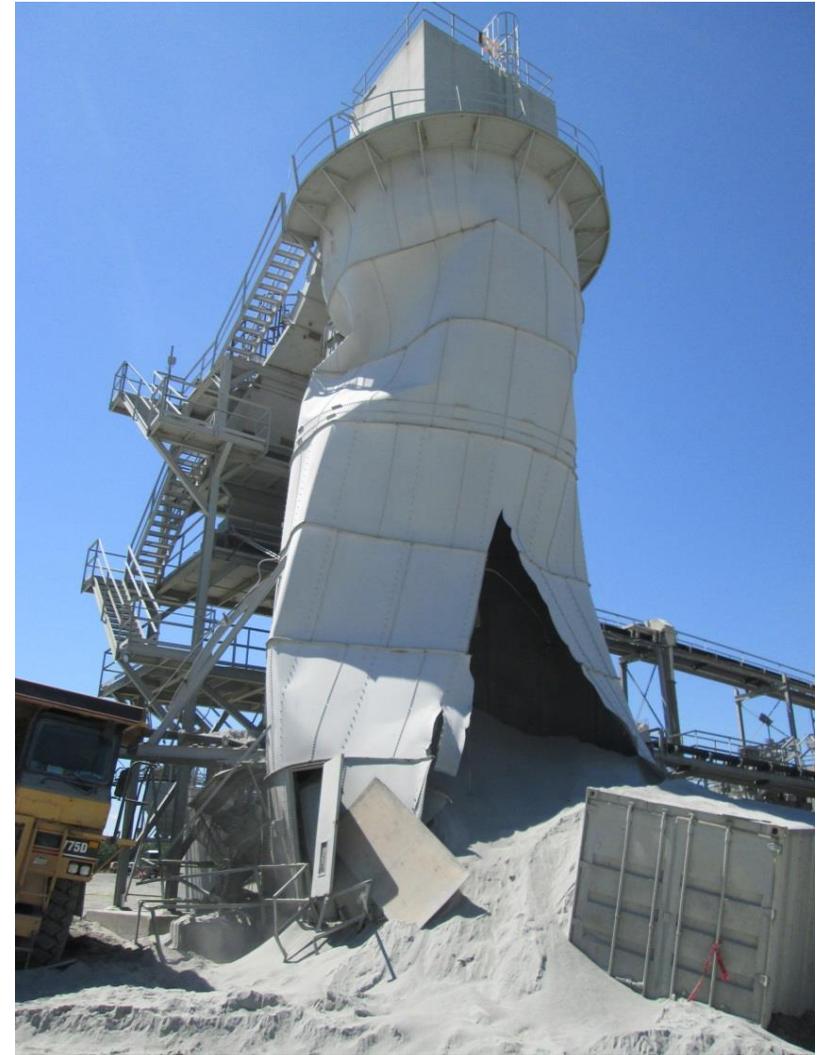
On August 3, 2015, at approximately 6:20 AM, an eighteen-year-old miner was fatally injured when the silo he was working under catastrophically failed. The lower cone section of the silo and its contents fell onto him and engulfed him. The silo was fully loaded at the time of the accident. Emergency medical and technical rescue teams responded to the site and initial attempts to locate and rescue the victim were unsuccessful. Further attempts to recover the victim were delayed until the silo structure could be stabilized. The victim's body was recovered from the accident scene at 11:41 AM on August 4, 2015.

Fatal Accident Scene

- DMM regulation **4 VAC 25-40-365** states, "Structures shall be of substantial construction and maintained in safe condition." DMM urges all mine operators and personnel to inspect structures to ensure they are substantially constructed in regard to their current use and that there is no evidence of damage or deterioration that may make them unsafe or unsound.
