VIRGINIA DIVISION OF MINERAL RESOURCES  
OPEN-FILE REPORT 07-01

THE TECTONIC HISTORY AND CHARACTERISTICS OF  
FRACTURE SYSTEMS AFFECTING  
COAL MINE ROOF STABILITY IN  
SOUTHWEST VIRGINIA

Craig B. Byington

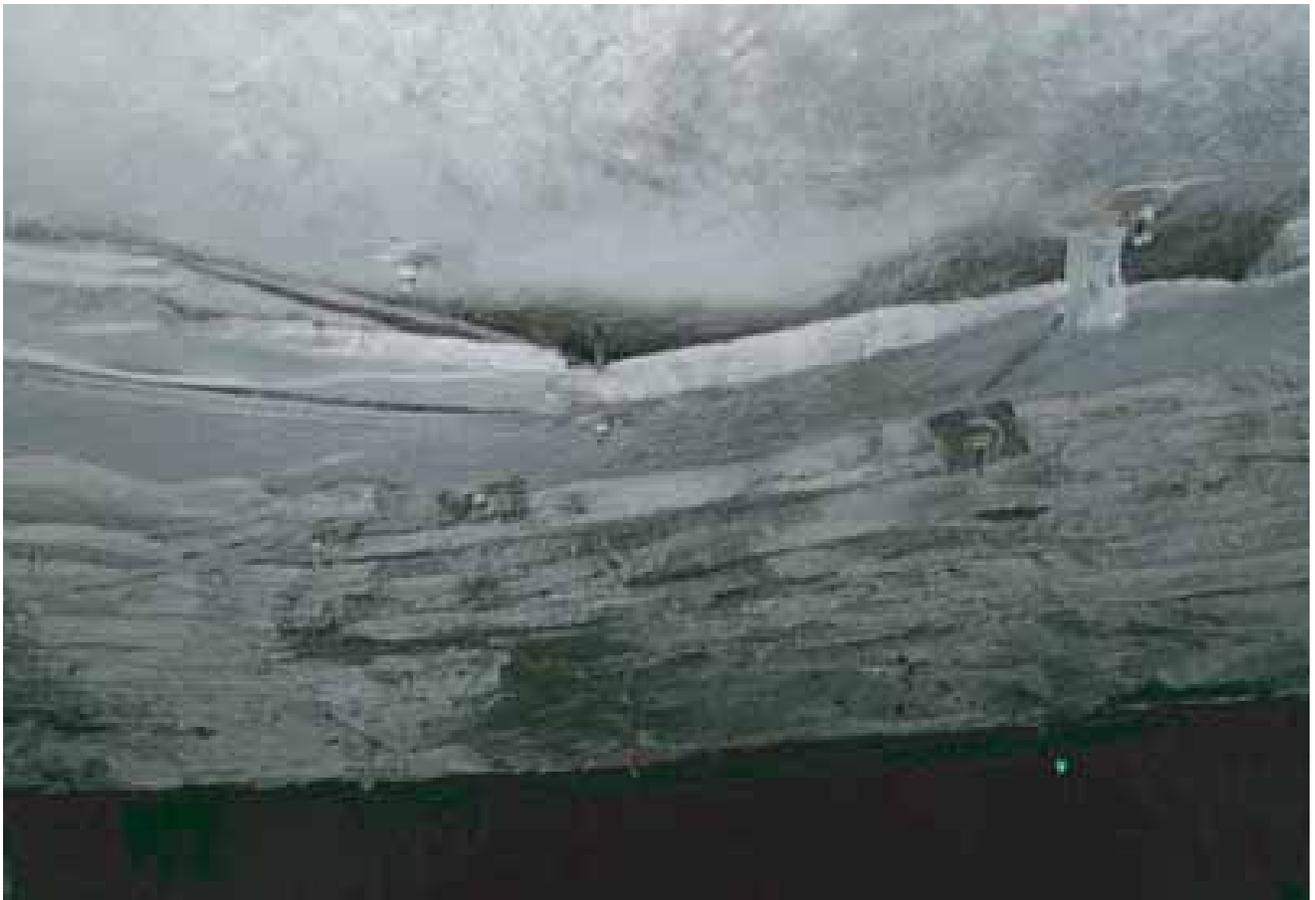
COVER: Roof-rock delamination along carbonaceous and micaceous micro-shear planes. Rock bolt plates for scale are 20 centimeters.

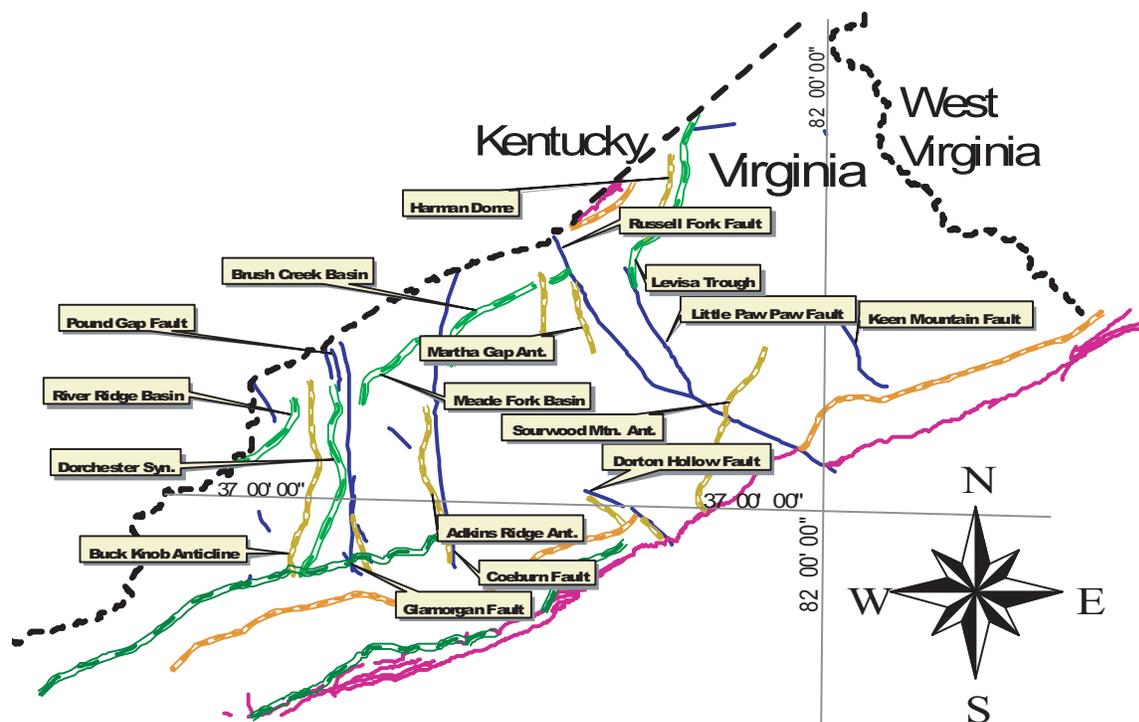
Figure 2. Structural map (not to scale) of the Southwest Virginia coalfields showing major faults (blue and purple), anticlines (tan and orange) and synclines (green) within study area (modified after Henika, 1994). Color choices are explained in text.

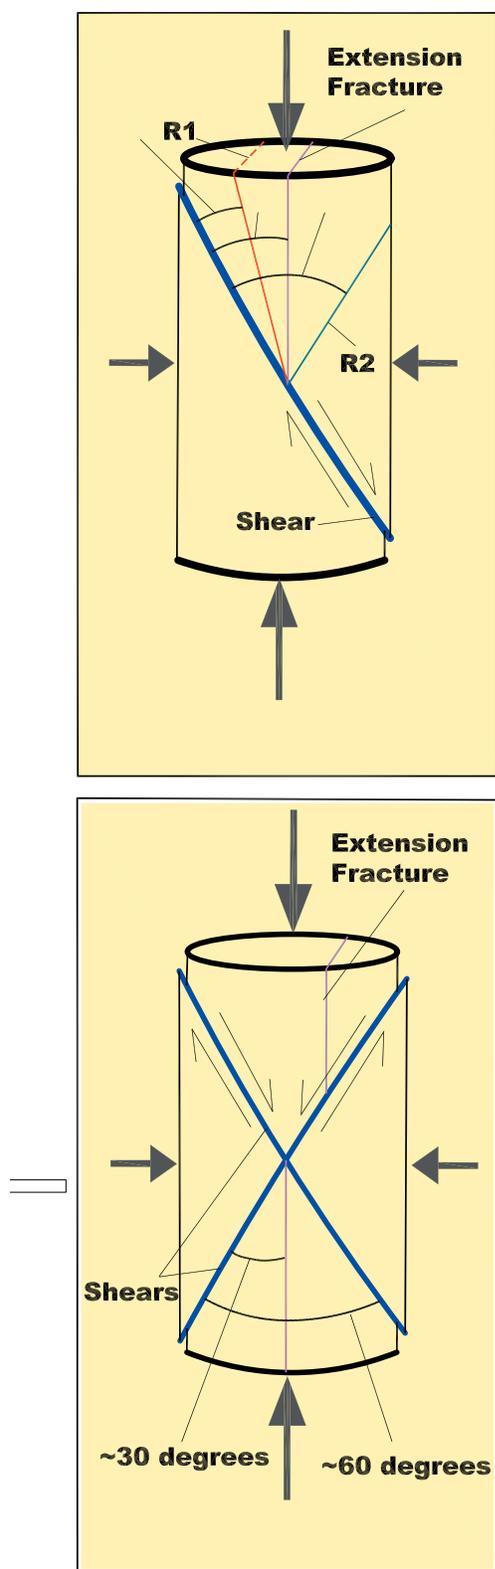
Figure 3. Schematic of pure shear at low-confining pressure (top) and high confining pressure (bottom) showing angular relationships (modified from Ragan, 1973; Sylvester, 1988; Twiss and Moores, 1992). Riedel shear planes in the simple-shear diagram are shown as R1 and R2.

Figure 3 schematically illustrates the geometric relationship of fractures with respect to rock failure in a brittle environment (Ragan, 1973; Sylvester, 1988; Twiss and Moores, 1992). The line describing the intersection of any two types of representative conjugate fracture planes with each other or with the main shear defines the orientation of  $\sigma_2$ . The slip direction is perpendicular to that line along the plane of the main shear (Ragan, 1973). These fractals are consistent at both macroscopic and microscopic scales (for example Tchalenko, 1970).

Local structural and fracture-filling characteristics reflect the general timing and geometric relationships. Kinematic indicators such as slickenside fabrics, marker-bed offsets, and many more of those described by Sibson (1989), were occasionally noted, but these were not used in computing the paleo-stress field or paleo-kinematics (Table II). For processing purposes the data were grouped according to fracture type, crosscutting relationships and permissible geometric relationships (see predicted angular relationships Figure 3).

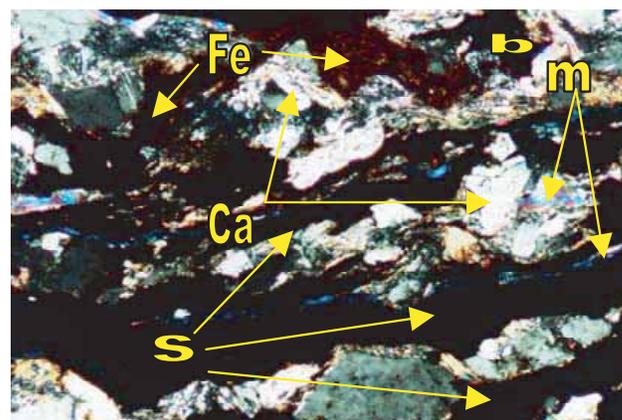
Figure 4. Transmitted light photomicrograph (crossed polarizer, 0.35 mm field of view) of sandstone in Tiller #1 mine showing calcite cement (Ca), siderite (Fe), realigned mica (m), primary coal blebs (b), and coal stringers (s).

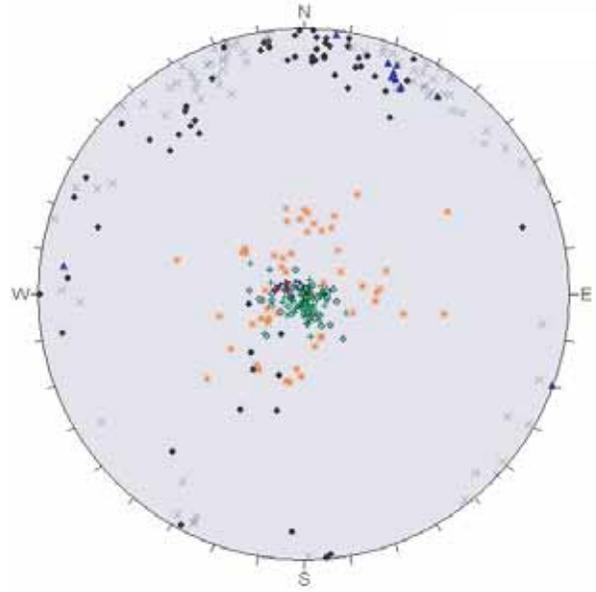
Figure 5. Stereonet plot of pole to planar data along State Highway 160 (n = 652). Faults (blue triangle), bedding (green cross), extension fractures (black dot), cleating (gray X), low-angle splay faults (light green diamond), riedel shears (orange asterisk) and intra-seam shears (red triangle) are plotted as poles.

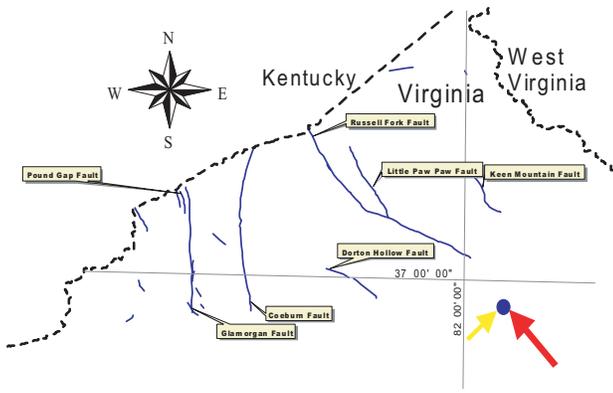
Figure 6a. Map showing D1 Faults (blue) and paleo stress field ( $\sigma_1$  = red arrow,  $\sigma_2$  = blue arrow, and  $\sigma_3$  = yellow arrow). Steep-plunging  $\sigma_2$  = strike-slip dominated faulting. Modified from Henika (1994).

The documented folding (Figures 6c and 6d) is consistent with the maximum compressive stress paleo-directions predicted for each event (note that the orientation of  $\sigma_1$  is similar in events D1a and D1b, see Table II). Folding, developed during event D1 (Figure 6c), follows the type and orientation associated with strike-slip faulting as predicted by Sylvester (1988) and Harding and Lowell (1979). In their models the fold axis wraps from near perpendicular to the strike of the faults in locations distal to the fault trace to an axis orientation approaching parallel to the strike in proximal locations to these transverse faults (compare Figures 6a and 6b).

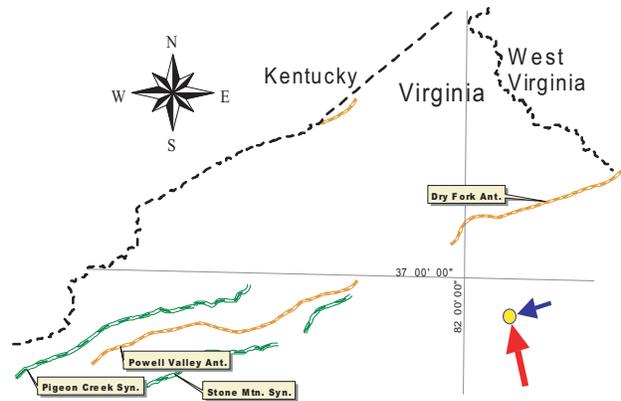
Figure 6d. Map showing D2 anticlines (golden) and synclines (green). Steep-plunging  $\sigma_3$  = reverse related folding. Modified from Henika (1994).

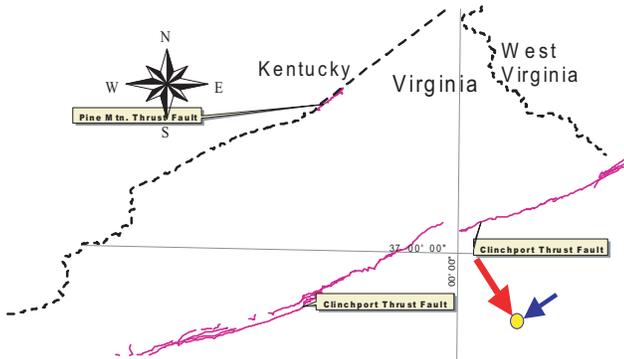
Figure 6b. Map showing D2 Faults (purple). Steep-plunging  $\sigma_3$  = reverse dominated faulting. Modified from Henika (1994).

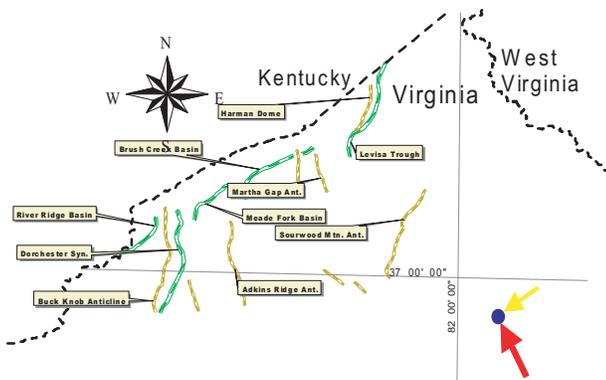
Figure 6c. Map showing D1 anticlines (golden) and synclines (green). Steep-plunging  $\sigma_2$  = strike-slip related folding. Modified from Henika (1994).

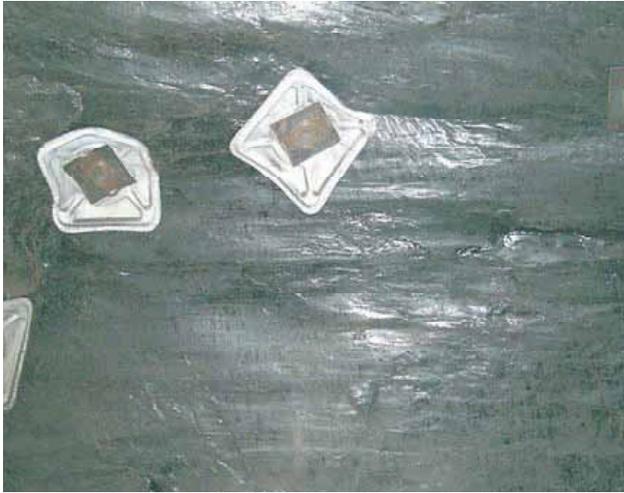
Figure 7. Near-vertical D1b shear plane coated with re-annealed coal (Deep Mine #6 mine). Note horizontal slickenside.

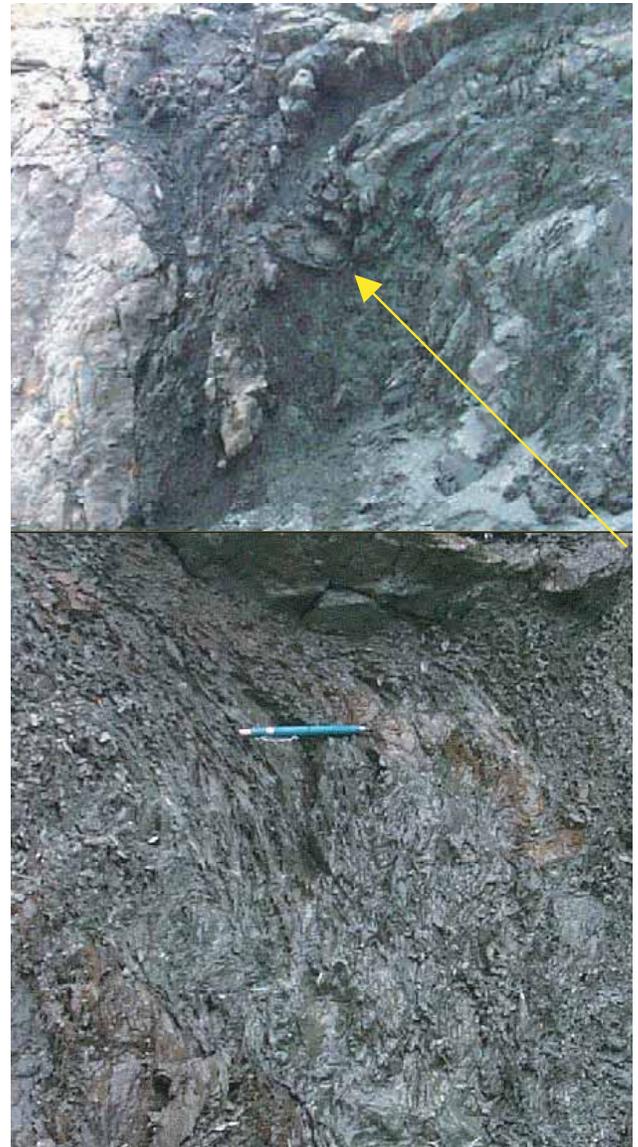
Figure 8. Pound Gap fault. **Upper** – Highway 23 road cut (4-meter field of view) showing clayey gouge (dark gray) separating arenite footwall (light brown) and shale hanging wall (green). **Lower** – close-up of gouge showing remnant riedel shears (faint, down-to-right linears, at left pencil tip) recording latest reverse displacement.

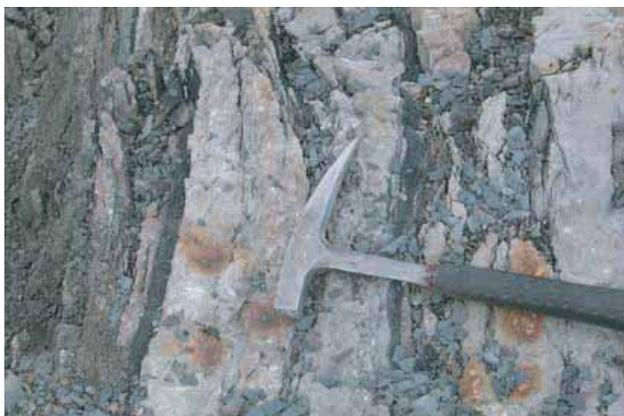
Figure 9. Black ultracataclasite injected into fractures (parallel to head of hammer) in footwall arenite of Pound Gap fault.

black, sandy and clayey cataclasite was injected into fractures in the arenite (Figure 9) or occurs as a hard, polished coating on the arenite fragments. The clay injections are late in timing and their geometry reflects right-lateral strike-slip (dextral) normal kinematics consistent with the calculated reactivation kinematics for event D2b

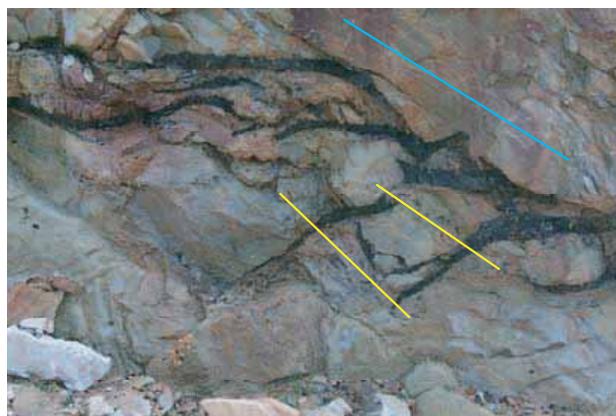
Figure 10. Pound Gap road cut (8-meter-wide view) of sulfidic arenite with coal injections adjacent to the Pound Gap fault. Visual identification suggests greenish and brown hues result from oxidation of disseminated sulfides to jarosite, and to limonite (dominantly goethite), respectively. Black coal injections cut sandstone bedding (cyan line upper-right quadrant) and conglomerate lenses (yellow lines) at high angles.

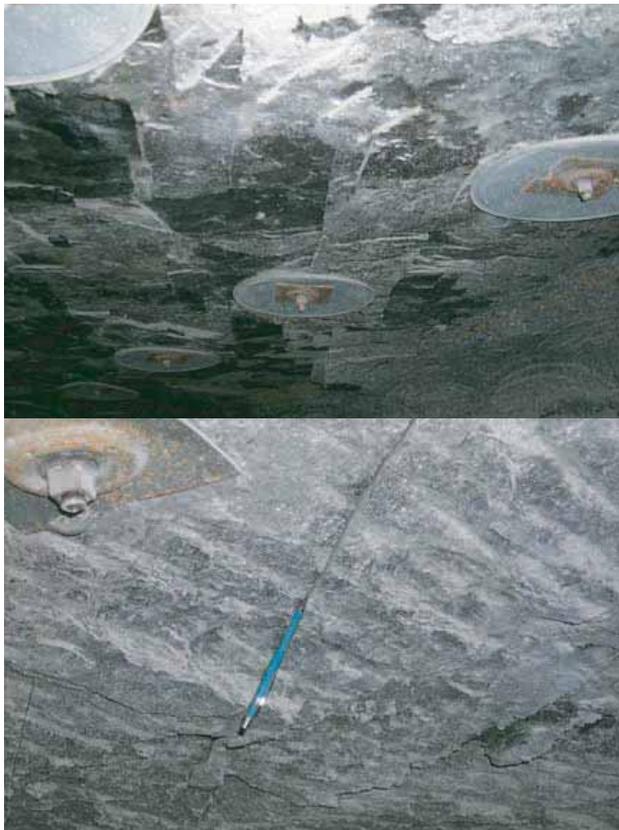
Figure 11. Roof extension fractures (Deep Mine #10 mine). **Upper** - swarm of HA extension fractures (striking directly away from viewer), and **lower** - single HA fracture (inserted pencil is 1 centimeter in diameter) of type involved with roof falls.

Fracture swarms consisting of up to hundreds of often very subtle HA extension fractures are typical near the core deformation zones of D1-type faults (Figure 11). These extension fractures are typically sub-parallel in strike and dip with respect to each other although they may

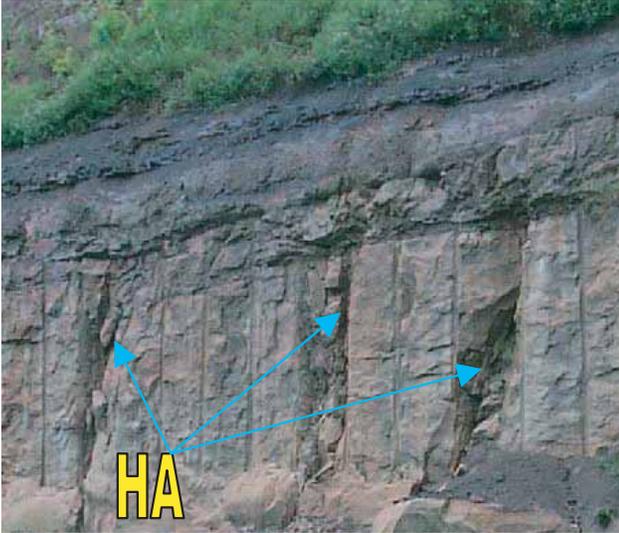
Figure 12. Road cut (State Highway 160) of arenite (brown) overlain by sheared graywacke bed (gray) and coal seam (black). Note that the high-angle fractures (HA) do not cut the highly sheared graywacke or the coal seam.

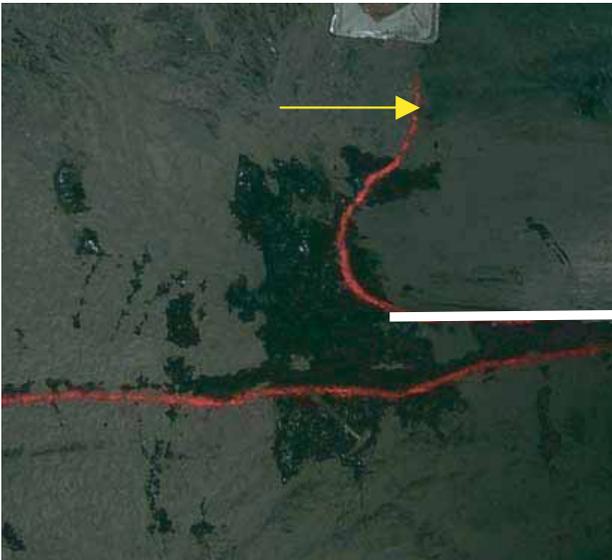
Figure 13. Cross-section view of fault intersection (Deep Mine #6 mine) of D1b fault at vertical paint line (yellow arrow) with D2 LA intra-seam shears (horizontal paint lines). Overhanging "brow" (upper right quadrant) is perpendicular to "right rib" and its bottom edge is marked by white line. Coal in upper-left quadrant is highly deformed.

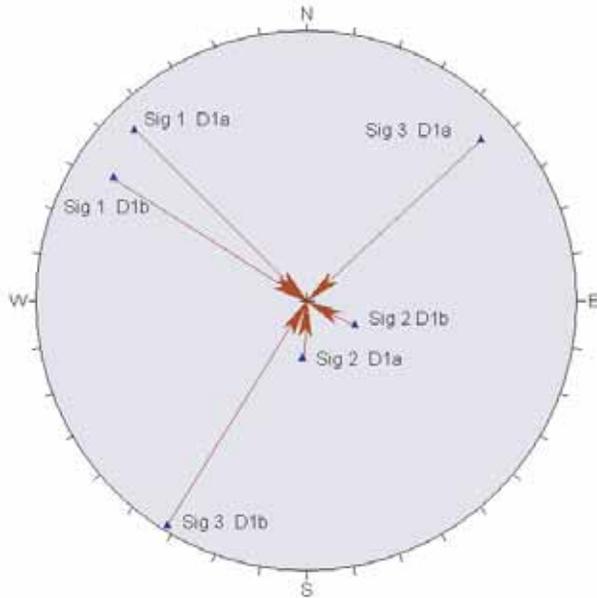
Figure 14. Stereonet plot of mean stress-field axes orientations for deformation sub-events D1a and D1b. (Sigma abbreviated as Sig).

Sub-event D1b exhibits a slightly different stress field orientation from that of sub-event D1a (Table II and Figure 14). In this case, there is a  $19^\circ$  counterclockwise rotation of the stress axes approximately about the D1a  $\sigma_1$  axis (specifically at 308, 13, right-hand rule). The timing and orientations of both face and butt cleating are consistent with their development as conjugate fracture sets during the D1 event. Poles representing sets of cleating orientations measured throughout the coalfield are clustered in two groups on a stereonet (Figure 15). The two mean cleating orientations are separated by an angle of  $62^\circ$ , and they are similar in orientation to those reported by Milici and Gathright (1982). One group with a mean orientation of 117, 84 (right-hand rule) aligns along the great circle girdle of event D1a indicating it is probably of the same stress field orientation as that of event D1a (for explanation of technique, see Byington, 2003).

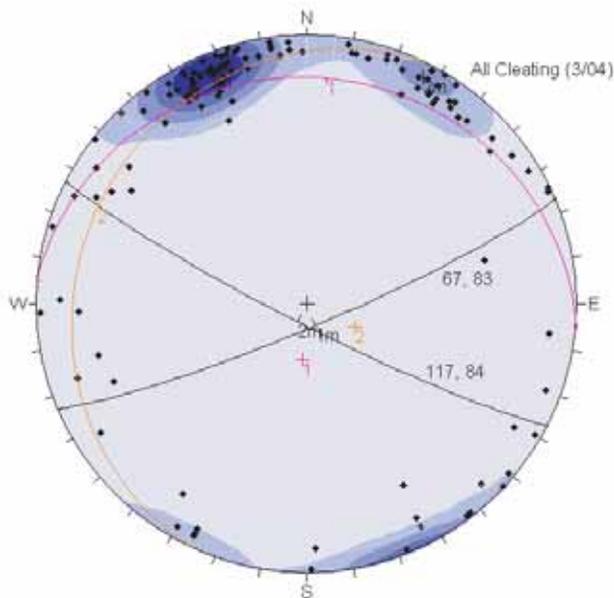
Figure 15. Stereonet plot ( $n = 257$ ) of face- (67, 83) and butt-cleating (117, 84) poles (black diamonds) with representative mean great circle orientations (black arcs). Great circle girdles for deformation sub-events D1a (magenta arc) and D1b (orange arc) are also shown.

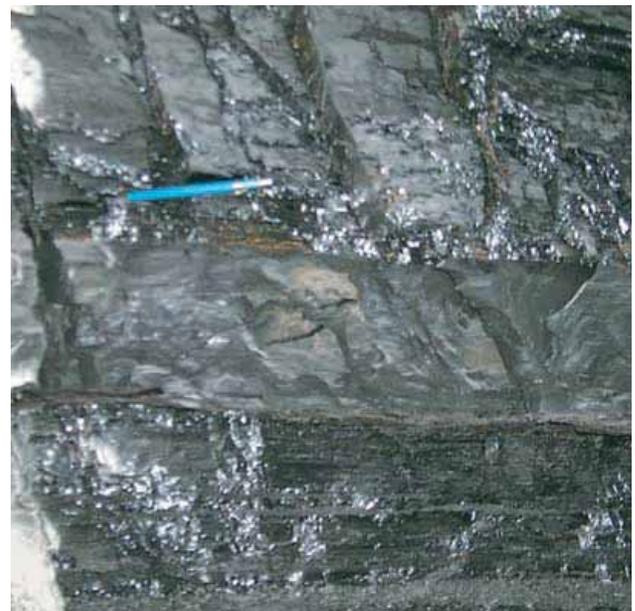
Figure 16. Imboden seam (Dorchester #4 mine) with thin well-sheared graywacke duplex sole (below blue pencil). Note strong cleating in the upper coal layer and no cleating in the lower coal layer.

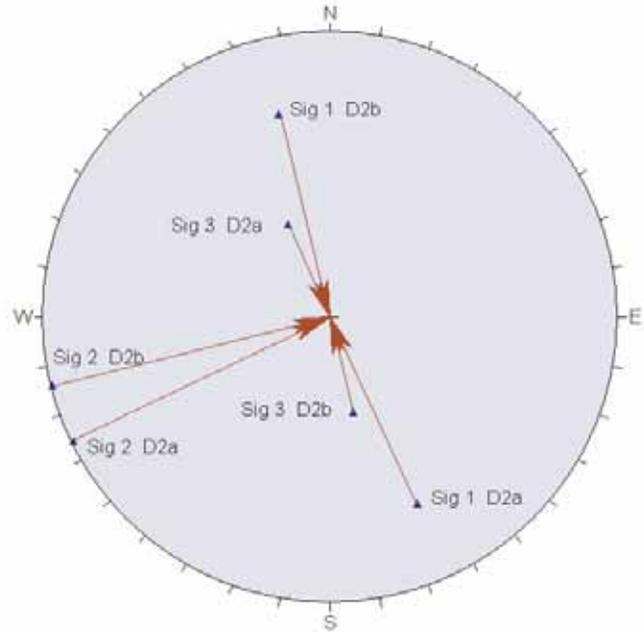
Figure 17. Stereonet plot of mean stress-field axes orientations for deformation sub-events D2a and D2b. Compare the orientations for  $\sigma_1$ ,  $\sigma_2$  and  $\sigma_3$  (shown as Sig 1, Sig 2 and Sig 3) with Figure 15.

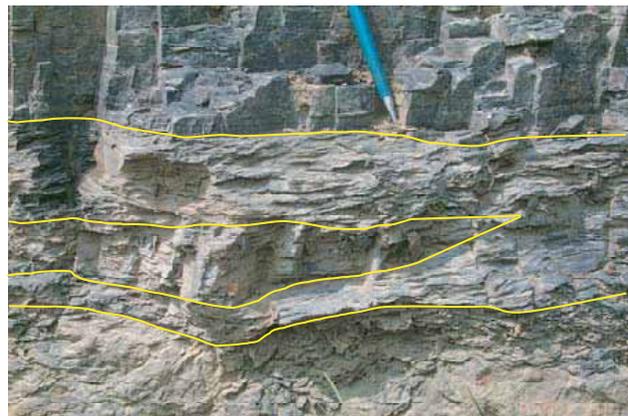
Figure 18. Coal seam (State Highway 160) showing orthomylonite-style shearing (highlighted with yellow lines) that cuts coal cleating (vertical) and destroys earlier primary and secondary structural fabrics. Note blue pencil for scale.

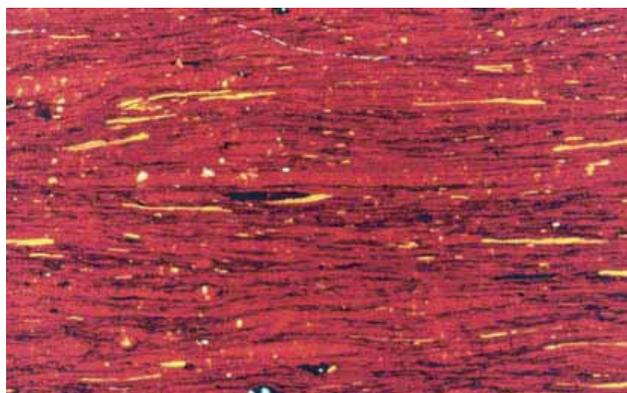
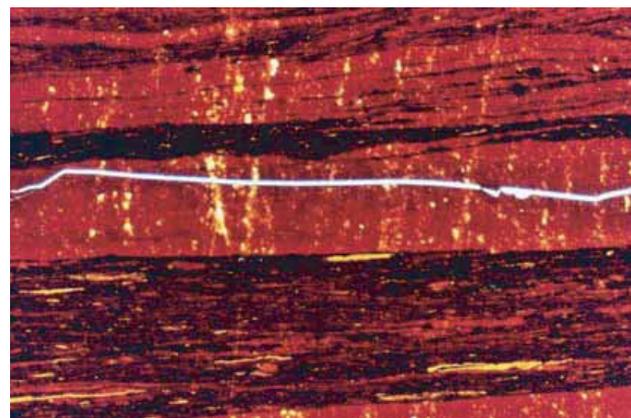
Figure 19. Transmitted-light photomicrograph (crossed polarizer, 0.75 mm field of view) with orthomylonitic fabric in coal showing translucent vitrinite (red) with stretched cutinite macerals (yellow) and opaque micro-shear planes (black streaks). **Upper** – Finely laminated anastomosing micro-shear planes with folded cutinite macerals, and **lower** – alternating bands of vitrinite and bands of micro-shear planes with contained micro-boudins (enclosed red blebs and lenses).

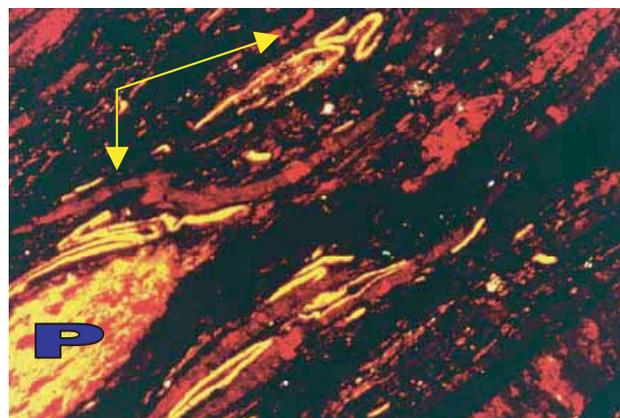
Figure 20. Transmitted-light photomicrograph (crossed polarizer, 0.75 mm field of view) of mylonite fabric in coal seam showing translucent vitrinite (red) with stretched and folded cutinite macerals (thin yellow) and opaque, anastomosing, micro-shear planes (black). Note the folded cutinite and vitrinite (arrows) around the nose of the lensoidal porphyroclast (P).

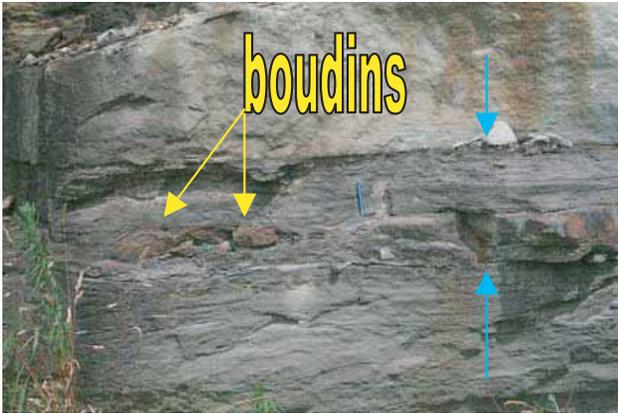
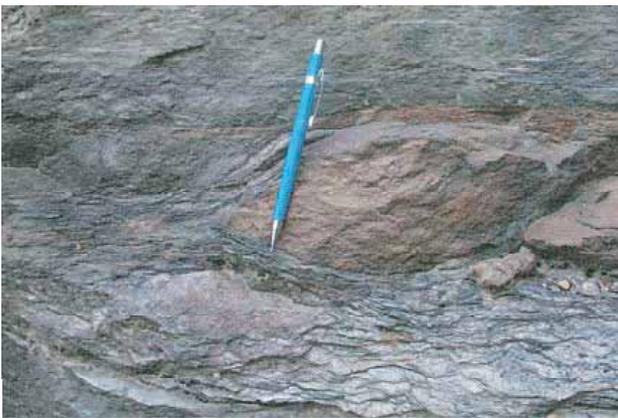
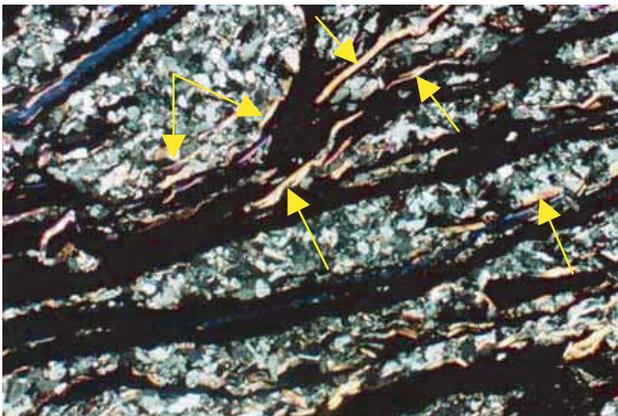
Figure 21. Mylonite zone (Highway 160) in arenite host showing: **Upper** - bedding parallel coal and mica streaked mylonite zone (between blue arrows) with internal sandstone boudins, **Middle** – close-up of local sandstone boudin illustrating the flow foliation, and **Lower** – photomicrograph (crossed polarizer, 0.75 mm field of view) of same mylonitic fabric in arenite showing anastomosing coal stringers (black streaks) and aligned mica (arrows).

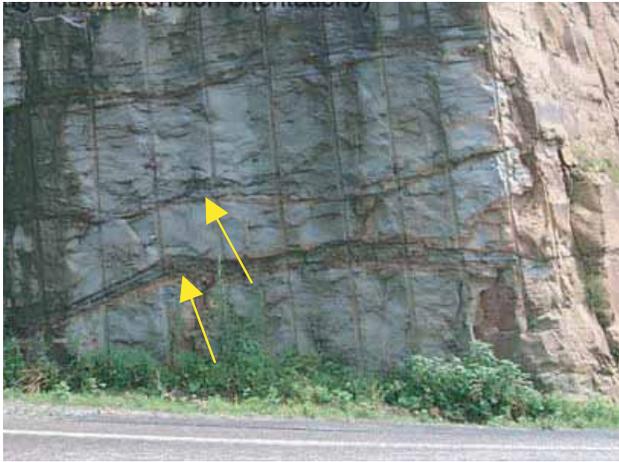
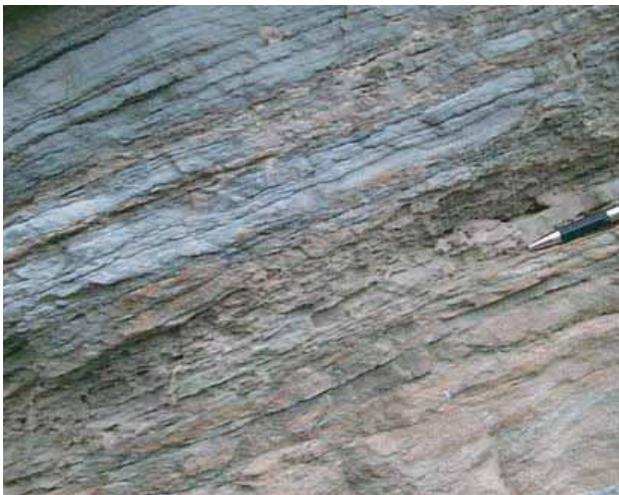
Figure 22. Three coal and mica lined mylonite shears in arenite along State Highway 160 road cut. **Upper** – shears inflect toward extension orientation (left of arrows). **Lower** - close up (lower arrow in upper photo) showing extension orientation of thin coal stringers in shear zone. Note pen point at middle right for scale.

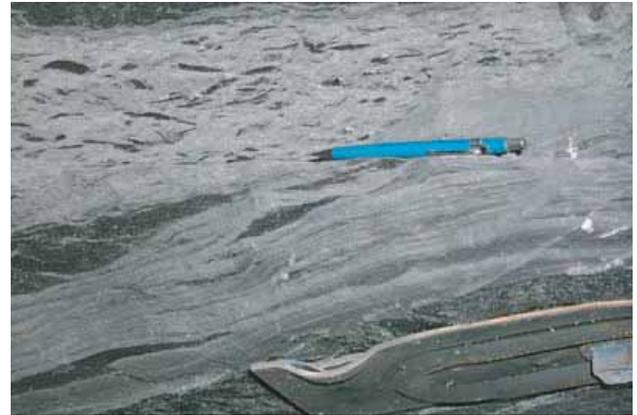
Figure 23. Reorientation of primary sedimentary carbonaceous fragments (above pencil) to shear-aligned coal stringers (below pencil) in arenite of coal mine roof (Laurel Mountain mine). Well-developed D2 thrust faults occur below rock-bolt plate.

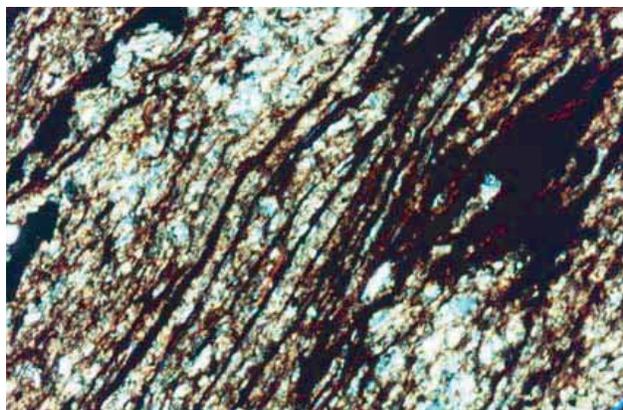
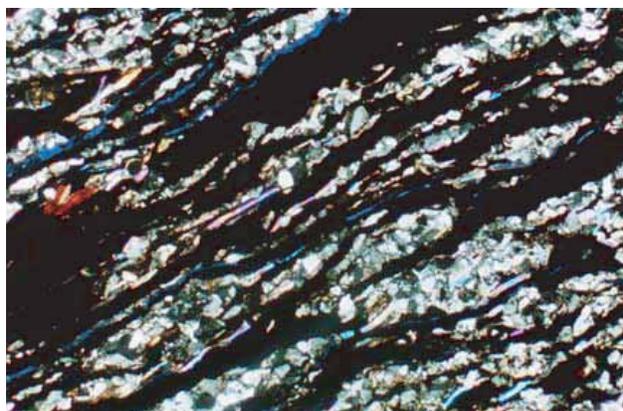
Figure 24. Transmitted-light photomicrograph (crossed polarizer, 0.75 mm field of view) of: **Upper** - graywacke with thin stringers of coal cutting through now-elongated blebs of coal, and **Lower** - arenite with anastomosing stringers of coal cutting through and elongating blebs of coal. All of the slivers of arenite “floating” in the coal are cemented with calcite.

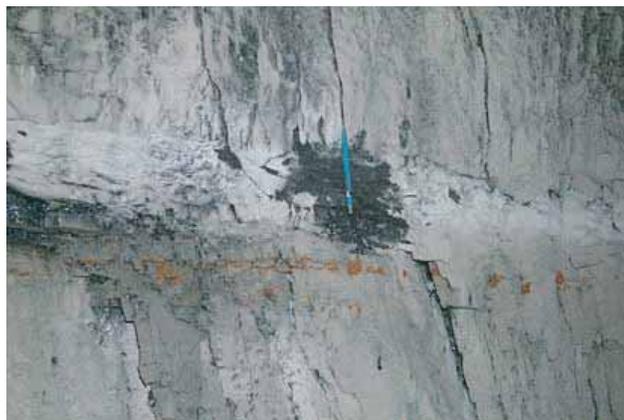
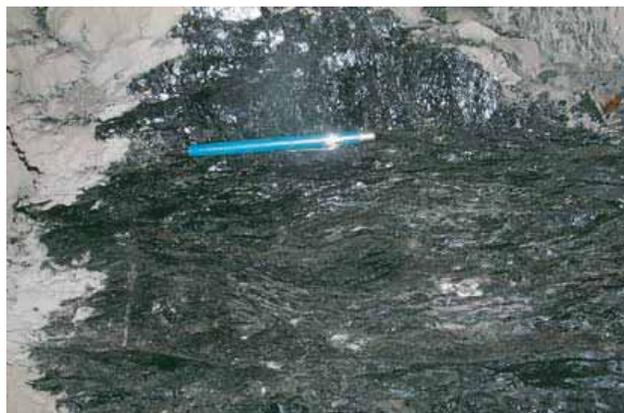
Figure 25. D2 intra-seam shear (below blue pencil, Deep Mine #6 mine). **Upper** – IS shear highlighted by rock dust coating (coating removed at pencil), and **lower** – close-up of rock-dust free zone showing “wavy” anastomosing characteristic of sigmoidal shear fabric.

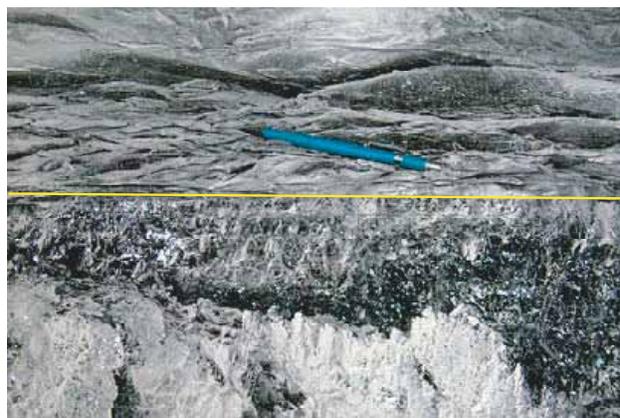
Figure 26. Intra-seam shear occurring above the upper coal seam contact (yellow line) within the Buchanan #1 mine. Note sigmoidal texture in core deformation zone in graywacke host (at pencil).

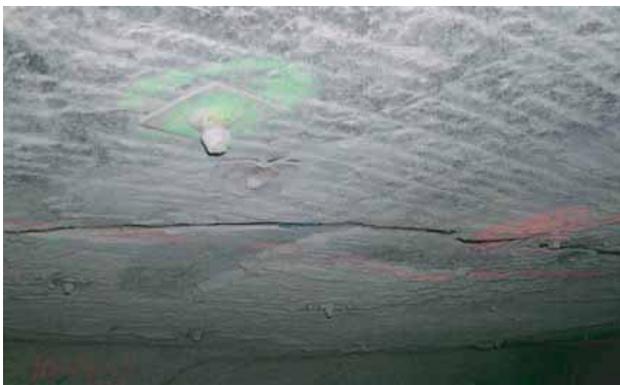
Figure 27. Typical appearance of LA extension fractures in roof (dark line). Fracture is inclined into roof away from viewer at a dip angle of 30°. Note 20-centimeter cable-bolt plate (green) for scale.

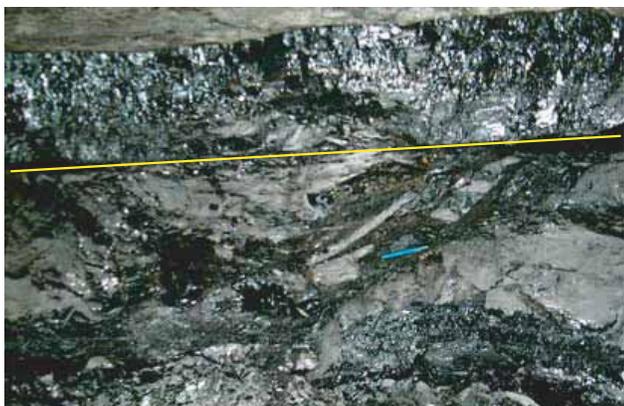
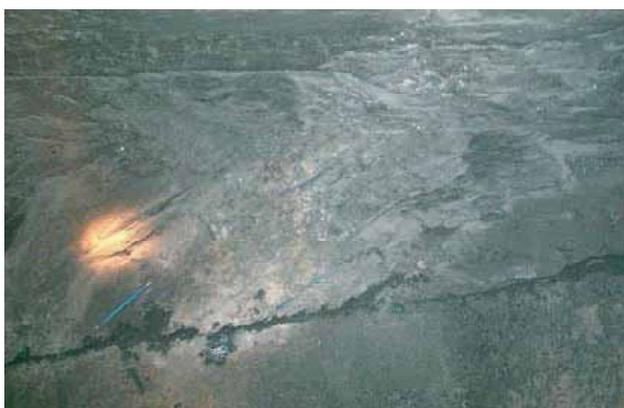
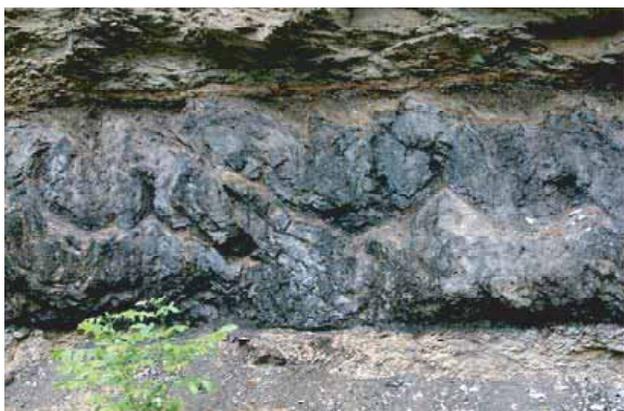
Figure 28. Duplexed coal seams. **Upper** – Relatively undisturbed upper coal layer (above yellow line) over folded and sheared (at blue pencil) lower Jawbone seam coal. **Middle** – Overriding layers of coal bounded by IS shear at top, middle (just below pencil) and bottom (not shown) of Raven seam producing local double thickness of coal seam. Note interconnecting riedel shears parallel to pencil (at orange cap light spot). **Lower** – imbricated and folded duplex of Kennedy seam producing 8X increase in thickness.

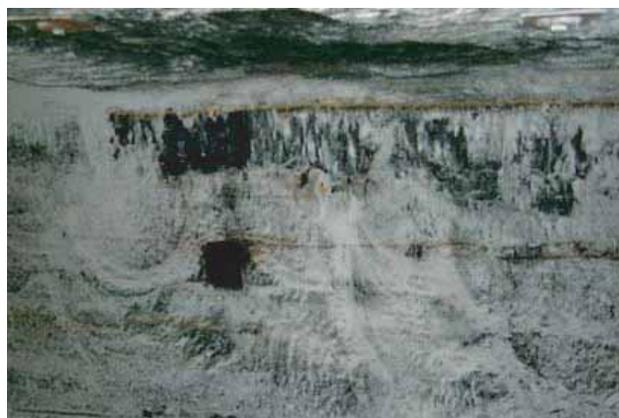
Figure 29. IS shears (horizontal brown lines) characterized by narrow glide plane and almost no conjugate extension fractures in roof.

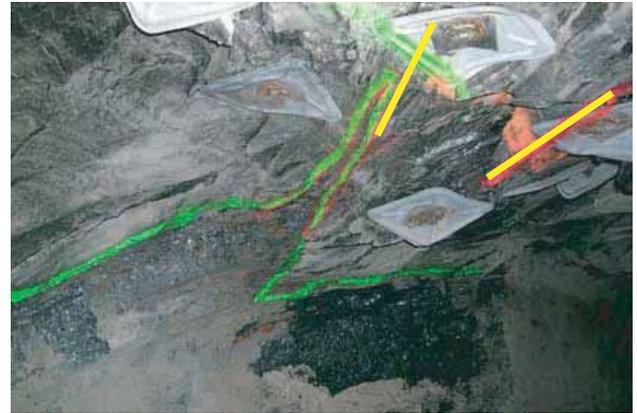
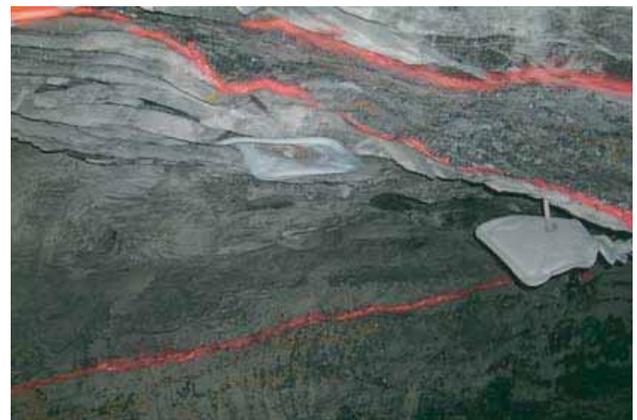
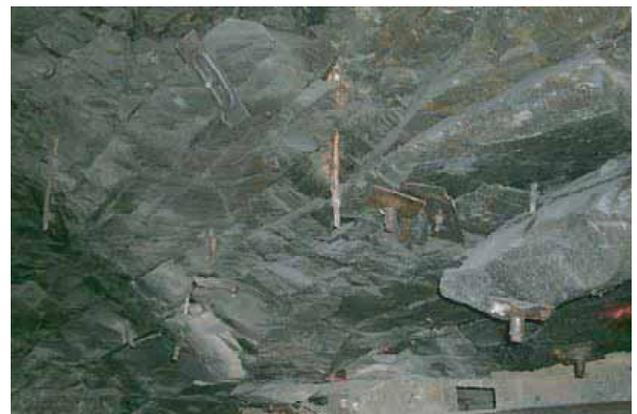
Figure 30. IS shear splays exiting coal seam into roof strata near roof falls. **Upper** – IS splay (Raven seam) exiting into roof arenite and “dragging” coal along with it (green paint along coal/host contact). Yellow lines indicate local bedding dip, which otherwise is near horizontal 10 meters in either direction perpendicular to bedding strike. **Middle** – Coal wedge (inside orange paint) cutting sandstone roof rock above near-horizontal main coal seam (lowest paint line). **Lower** – Highly fractured roof associated with IS splay fault exiting into roof (Jawbone seam).

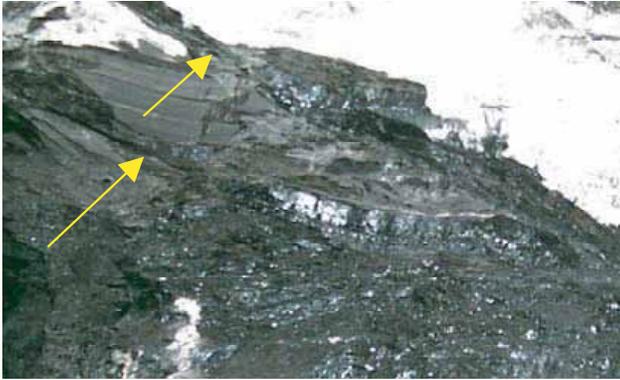
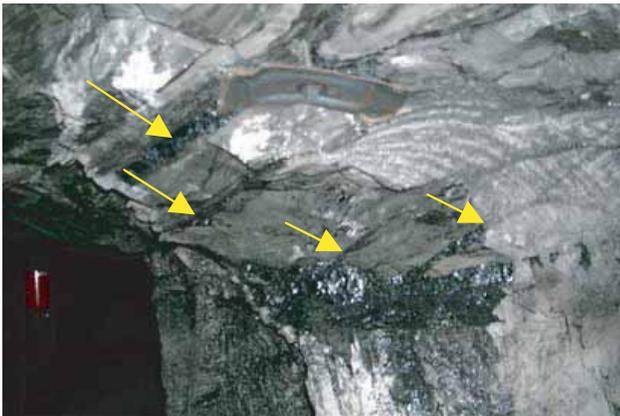
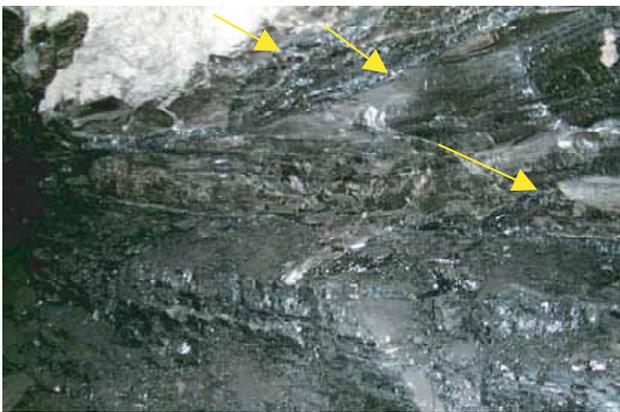
Figure 31. Coal-stringer-filled extension fractures cutting bedding (at arrows). **Upper** –Raven seam. **Middle** –Jawbone seam. **Lower** – Imboden seam.

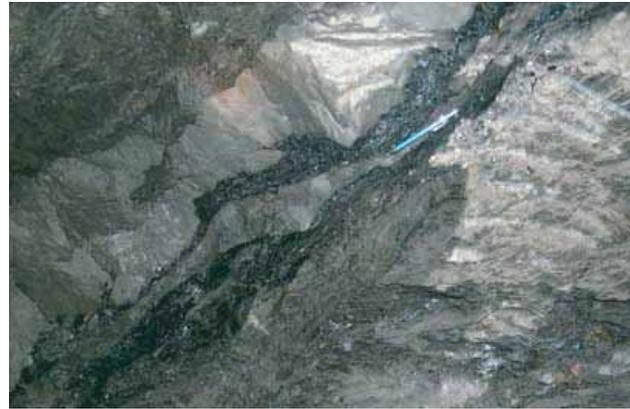
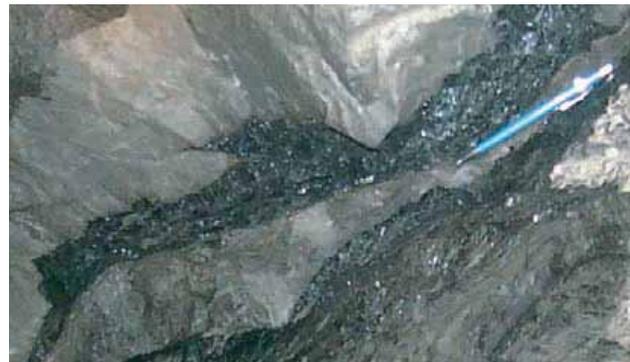
Figure 32. Coal stringers showing angular contacts resulting from injection into sandstone host.

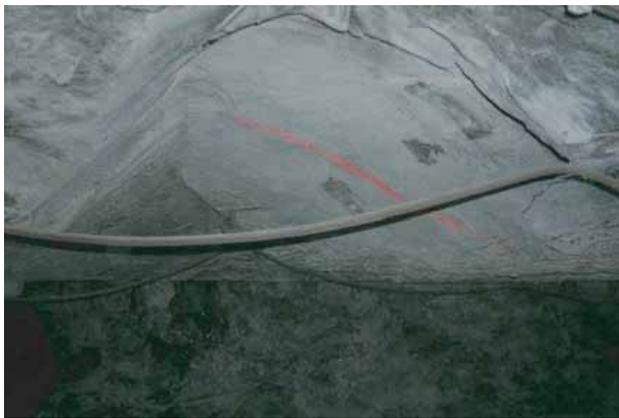
Figure 33. Pyramidal void (“horse-back” void) caused by intersecting extension fractures of sub-events D2a and D2b.

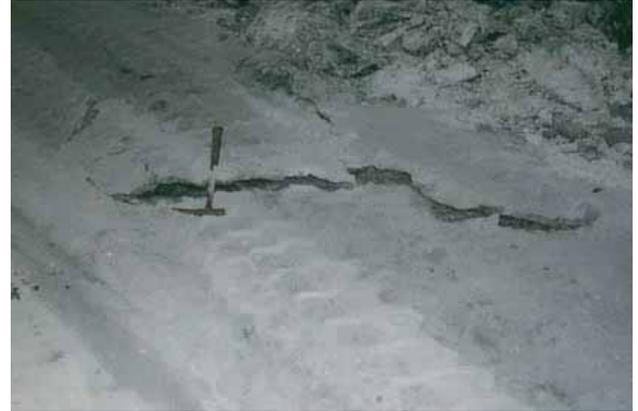
Figure 34. Floor buckling along LA extension fracture. Fracture is polished and clay lined. Note hammer for scale.

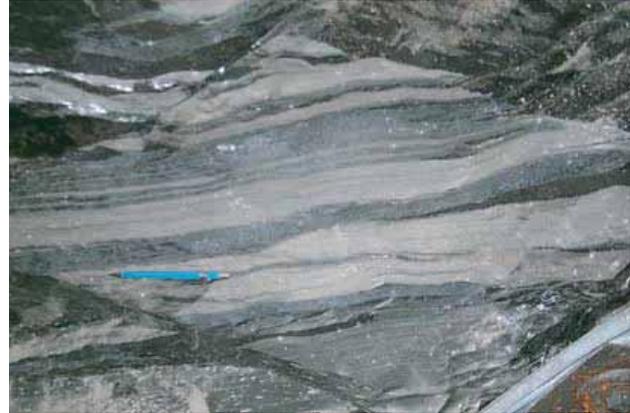
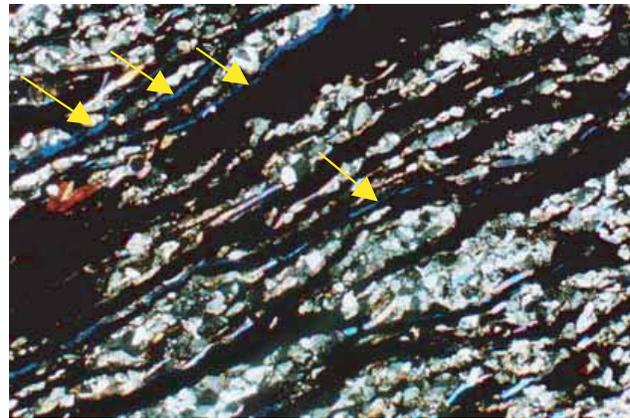
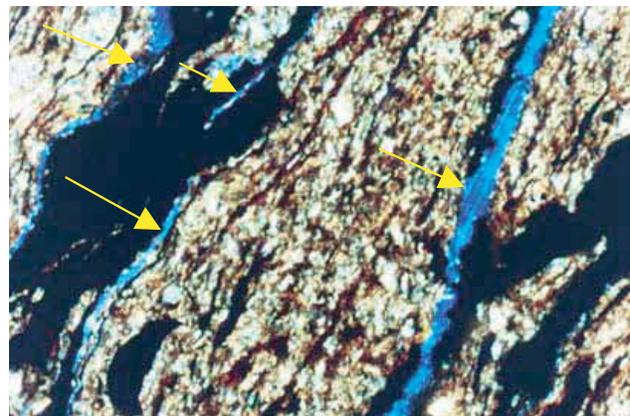
Figure 35. Bands of coal micro-stringers in arenite host (**upper**). Transmitted light photomicrographs (crossed polarizer, 0.75 mm field of view) showing anastomosing coal stringers in arenite (middle), and in graywacke (lower). Deep blue streaks at the coal/host rock contacts are open fracture delaminations (at arrows).

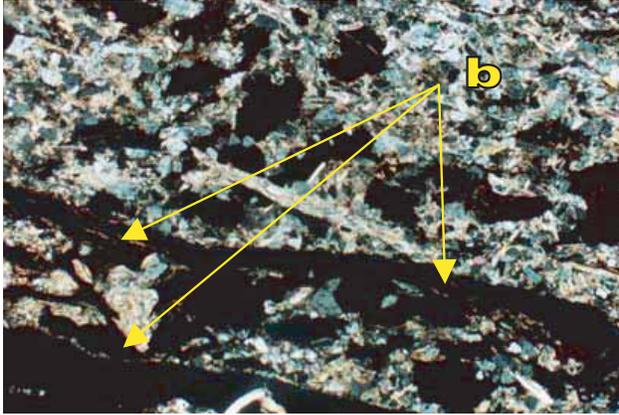
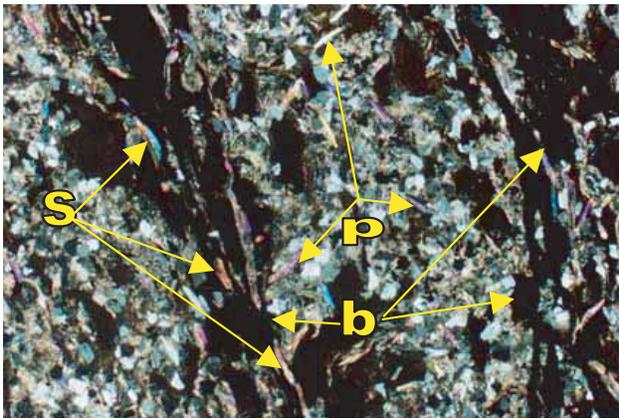
Figure 36. Transmitted light photomicrograph (crossed polarizer, 0.75 mm field of view) showing anastomosing coal stringers and blebs (black) in arenite. **Upper and lower** – stringers cutting and locally remobilizing pre-existing coal blebs (b). **Lower** - primary mica grain orientations (p) have been realigned (s) resulting from shearing directly adjacent to the fractures.

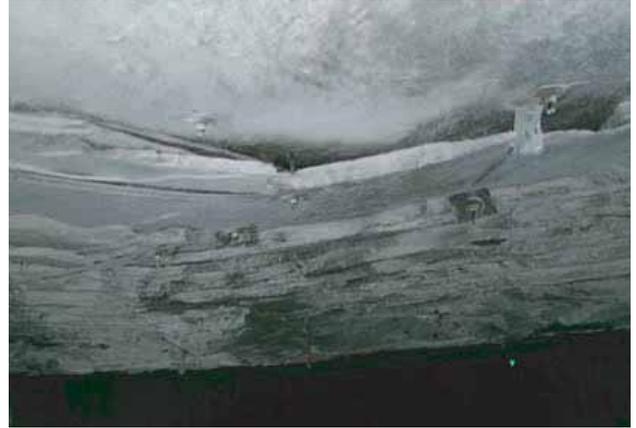
Figure 37. Roof-rock delamination along carbonaceous and micaceous micro-shear planes. Rock bolt plates for scale are 20 centimeters.

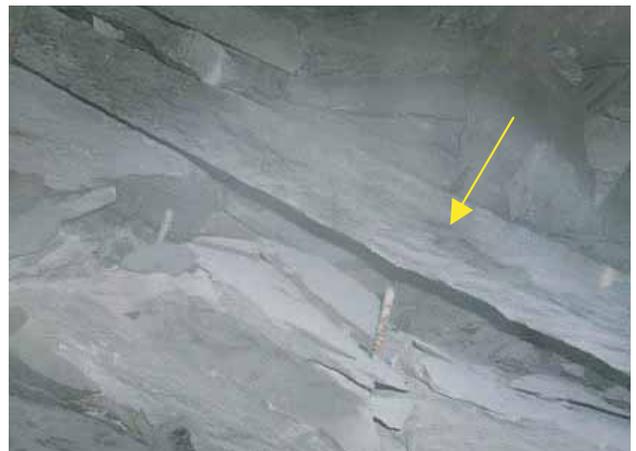
Figure 38. Roof fall with tabular blocks indicative of roof delamination. Note the fine coal micro-stringer laminations evident as black, wispy, anastomosing fabric (arrow) in very tabular block.
