Vol. 29

November 1983

NARROWS LANDSLIDE, GILES COUNTY, VIRGINIA

W. Jerrold Samford

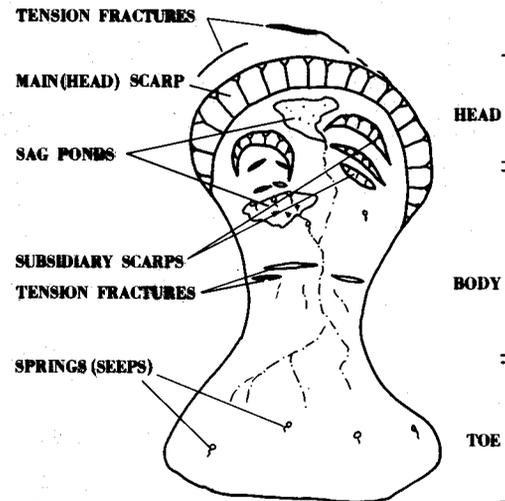
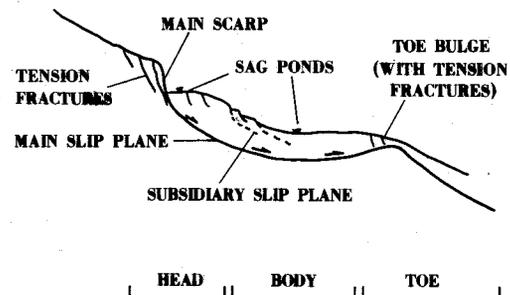
Figure 1. Generalized sketch of an idealized landslide.

"Landslide" has become a general term for any one of a number of types of downslope movement of soil or rock under the influence of gravity. Movement typically occurs along a distinct basal slip plane which separates the body of the landslide from the undisturbed soil or rock. Figure 1 is a generalized sketch of an idealized "landslide" showing morphologic features and terminology used in this article.

The head of a landslide is characterized by downward motion which exposes the main (or head) scarp. If the motion at the head of the landslide has a rotational component, a closed depression may be formed which, if subsequently filled by rain water or ground water, forms a sag pond. Movement at the toe of the landslide is characterized by upward bulging (toe bulge) and lateral spreading. Tension cracks form at the toe due to the outward component of motion. The body of the landslide is characterized by subsidiary motions paralleling the head scarp. These motions are minor "landslides within landslides" and show all the main components previously described.

The main scarp of a landslide is typically arcuate in plan and narrows to the toe area. If the accumulated debris at the toe tends to fan out, an "hourglass" shape may result. Otherwise, the debris at the toe tends to buttress the body of the landslide against further movement. Excavations at the toe of the landslide, which remove this

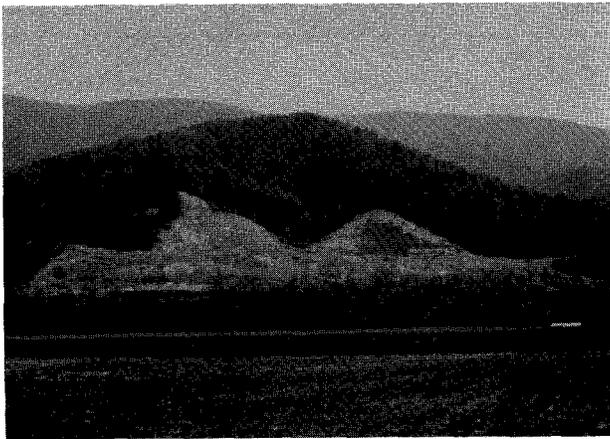
Figure 2. View of the Narrows landslide, looking north from the south bank of the New River. Eastern half of the cleared slope is not involved in current movements. Turnhole Knob is immediately behind the landslide and Peters Mountain is in the background.

The landslide affects about 2,000 feet along U. S. Highway 460 and extends approximately 400 to 700 feet north above the highway and about 200 feet below the highway to the New River. Turnhole Knob and Peters Mountain rise to the north of the area; Wolf Creek and Pearis mountains rise to the south. The New River locally flows from east to west, parallel to U. S. Highway 460, south of the slide area.

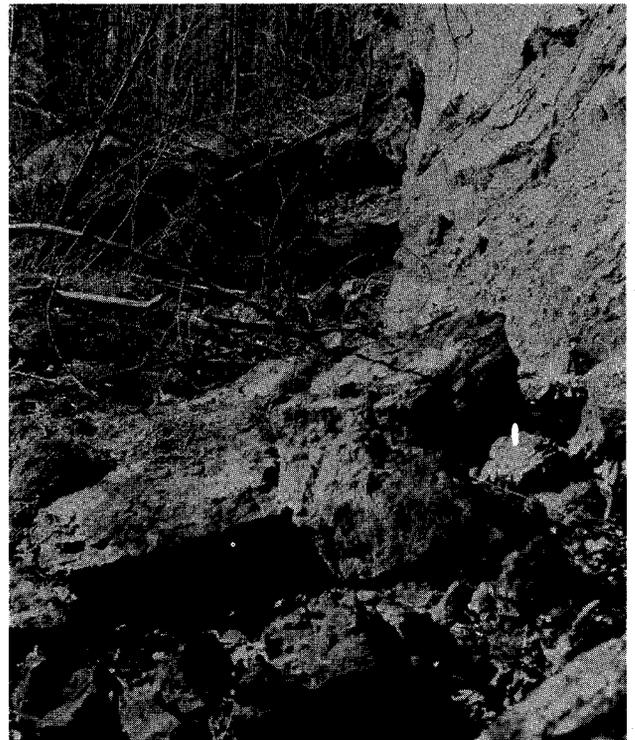
Figure 5. Block fall along the main scarp of the Narrows landslide. This portion of the scarp is about 10 feet high.

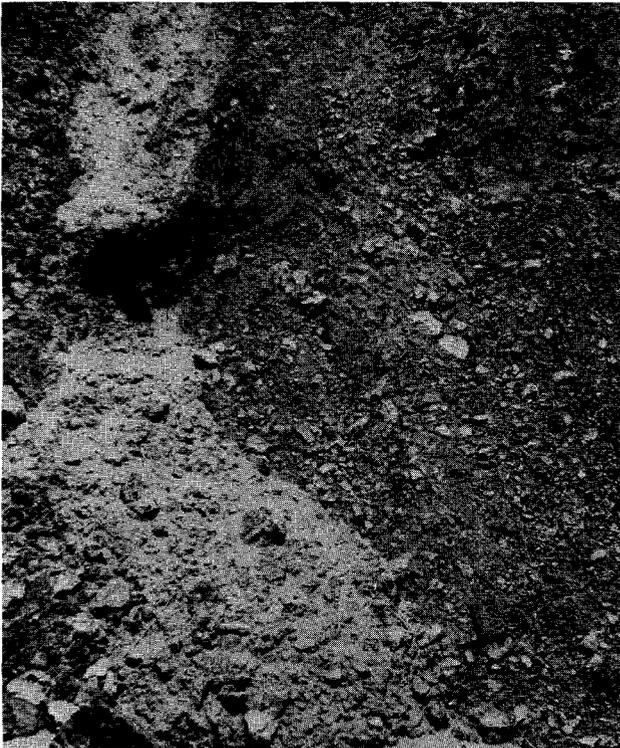
Figure 6. Mudflow in the Narrows landslide. This mudflow was located in the nearly vertical cut made for U. S. Highway 460. Height of the cut at this locality is about 8 feet.

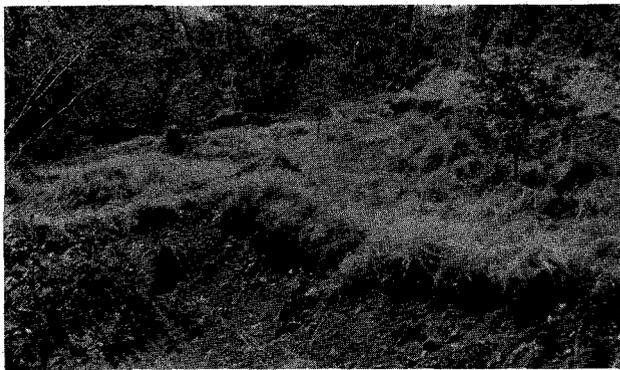
Figure 7. Hummocky topography and en echelon scarp formation in the Narrows landslide. This style of motion appears to be restricted to the western half of the landslide and to material which may be generally colluvial in nature.

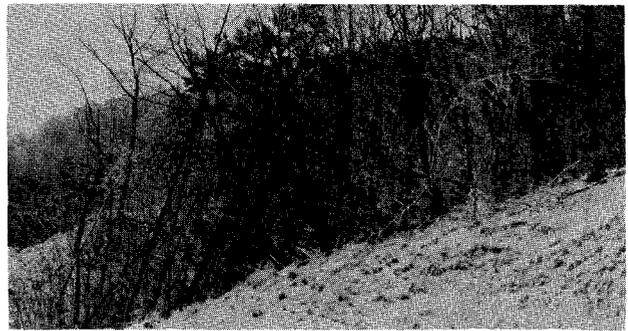
Figure 8. Rotational slump feature of the Narrows landslide. Tilted trees in the left foreground illustrate a clockwise rotation of a slump block, U. S. Highway 460 is out of the photo to the left.

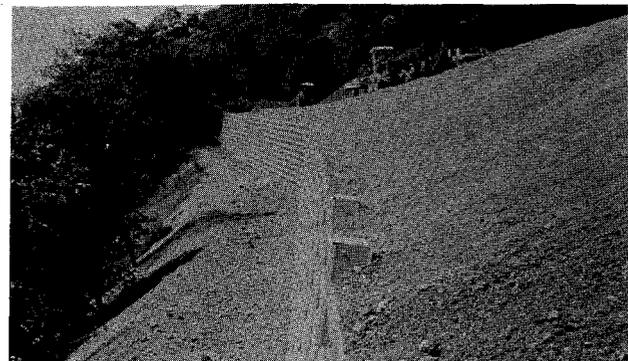
Figure 9. Completed Armco bin retaining wall. Notice the regular alignment of the wall. Photo courtesy Carl Kuehn.

the major movements in 1971, a 400-foot long "Armco bin-type metal wall" was constructed. This wall required an excavation 400 feet long, 20 feet deep and 40 feet wide. It was placed at the south edge of the east-bound lanes of the newly widened U. S. Highway 460 to support not only the hillside, but also the roadway. To brace the excavation, steel "H" piles were driven 40 feet deep on 4 foot centers along the centerline of the eastbound lanes of the highway. Once the excavation was complete, timber lagging was emplaced between the piles to further support the cut. The bin wall was subsequently installed and the bin backfilled with "porous free draining material such as commercial aggregate No. 8" (Meadors, 1971) (Figure 9). Shortly after construction, the wall began showing considerable distress (Kuehn, personal communication, 1981). The wall has bulged out of line, there are tears in the sheet metal allowing piping of the gravel backfill, and numerous bolts have been bent and/or sheared (Figures 10 and 11).

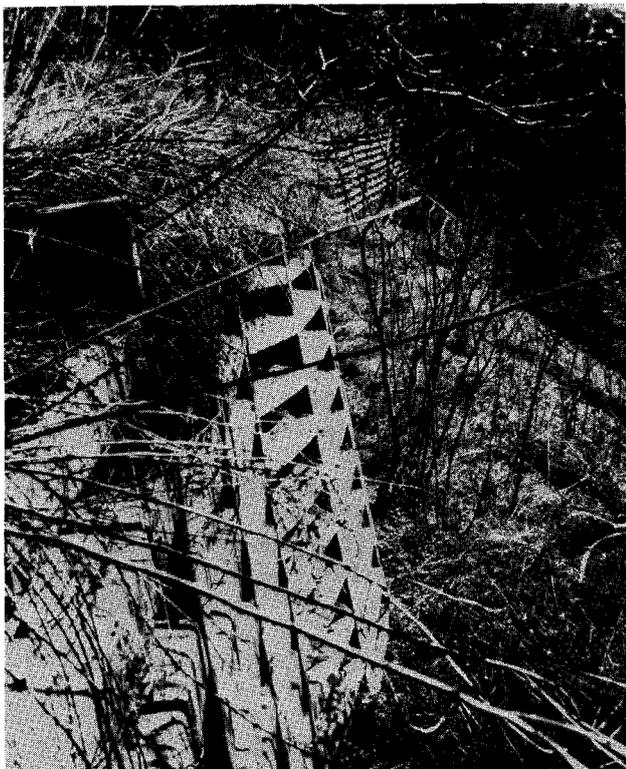
Figure 10. Alignment of Armco bin retaining wall in April, 1981.

In response to the stress in the retaining wall the VDHT removed an estimated 250,000 cubic yards of material from the landslide to relieve the "overburden" pressure on the unstable mass and reduce the slope angle. In conjunction with this effort, drainage was planned for the landslide but never installed. One of the significant factors contributing to most landslides is the presence of excess water, and investigations into the causes of landsliding should always include evaluation of the groundwater situation within the unstable mass. Sowers and Royster (1978) state that "identification of the source, movement, amount of water, and water pressure is as important as identification of the soil and rock strata [in a landslide]."

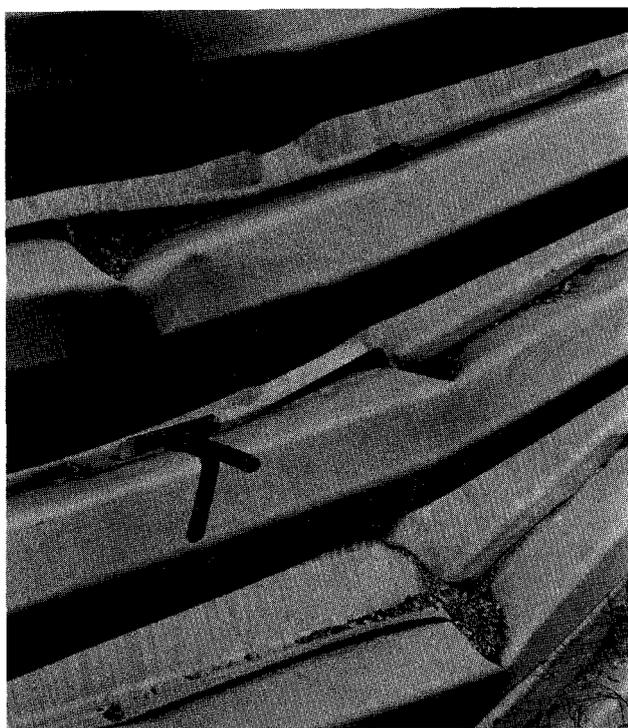
Figure 11. Distress in Armco bin retaining wall. Notice the tears in the sheet metal, the sheared bolts and the piping gravel. Geologic hammer is for scale.

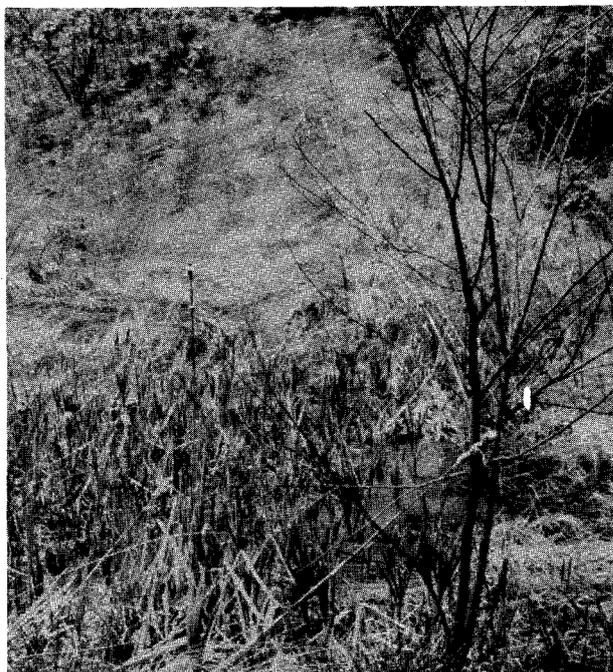
Today there are several "sag ponds" on the surface of the landslide which formed when rotational slumping created a depression at the head of the slump filled with water. These ponds allow seepage of water into the landslide, contribute to its instability, and indicate ongoing movements (Figure 12).

Figure 12. Sag pond in the Narrows landslide. Ponds such as this allow slow seepage of water into the disturbed soils.

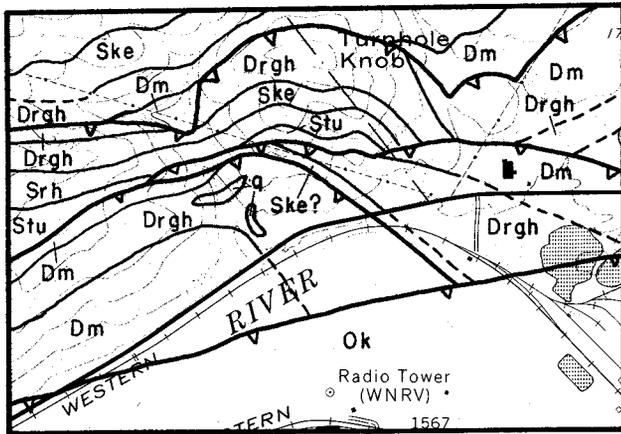
Figure 13. Geologic map of slide area (Lewis, in progress). Units are: Ok, Knox dolomite; Stu, Tuscarora Formation; Srh, Rose Hill Formation; Ske, Keefer Sandstone; Drgh, Rocky Gap Sandstone/Huntersville Formation with q, quartzite lenses; and Dm, Millboro Shale.

performed by Cooper (1961), Hale (1961), and is currently being revised by Lewis (in progress). The Narrows landslide has formed in severely brecciated and overturned strata of the Silurian Rose Hill Formation (Figure 13).

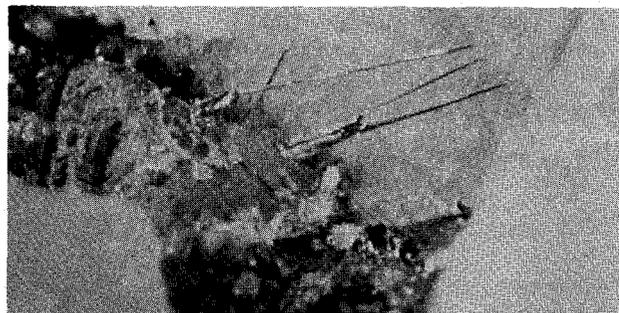
Millerite occurs as slender gold colored rod or needle-like crystals up to 2 mm in length (Figure 2). The mineral was found in a ferroan dolomite vein in the soapstone associated with chalcopryrite (copper sulfide). Millerite is a subordinate ore of nickel.

Figure 2. Needle-like crystals of millerite (nickel sulfide) attached to chalcopryrite. "Stadia rod" appearance of one crystal is produced by rotation around c-axes. White area is ferroan dolomite. Longest crystal is 1.75 mm (Photo by T. M. Gathright, II).
