DMM Safety Alert: **Electrocution Near Miss**

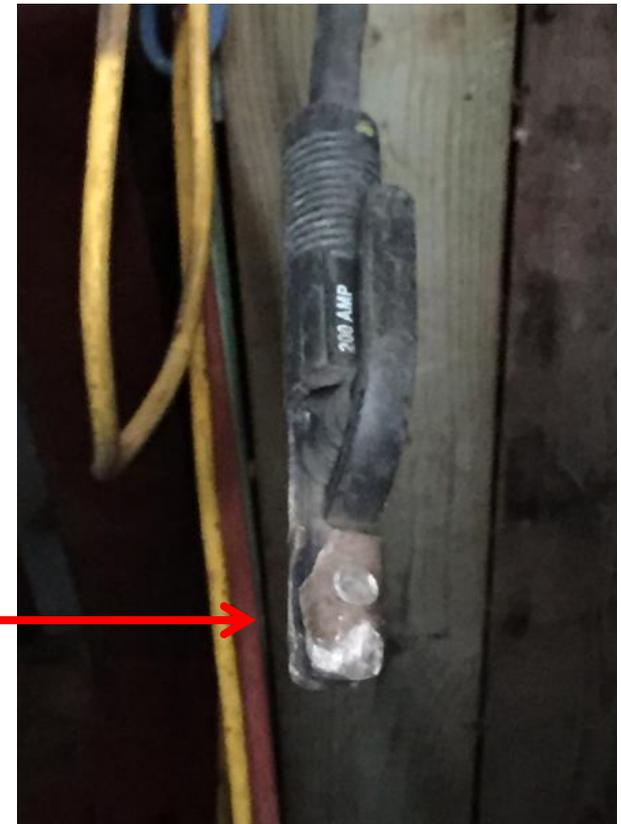
Electrode holders and leads with missing or deteriorated insulation should be repaired or removed from service!!

- Miners must conduct pre-operational inspections of their tools and equipment prior to use each shift. Any defects found must be reported to the certified foreman and defective equipment removed from service or properly repaired prior to use.
- Task training for welders should include the importance of maintaining leads, clamps, and electrode holders in order to minimize shock hazards.
- Welders should be cautioned when working in hot and/or wet environments to be mindful of the increased risk of shock due to sweat and water soaked clothing and skin.
