Virginia Minerals

NOVEMBER 2005

A PRELIMINARY INVESTIGATION OF THE CHIMBORAZO HILL LANDSLIDE OF AUGUST 30, 2004

Mark W. Carter and C. R. Berquist

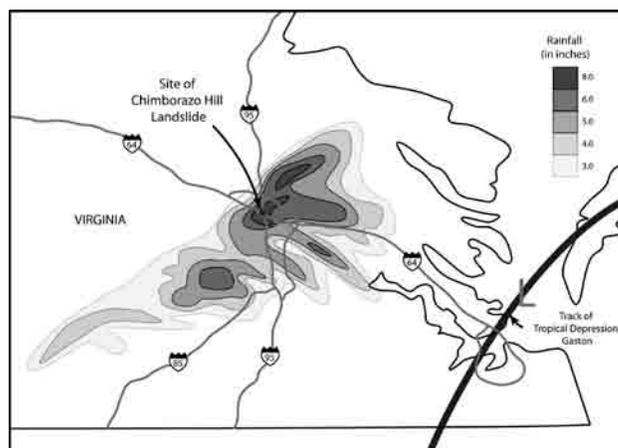
Figure 1. Intense rainfall distribution from Tropical Depression Gaston, August 30, 2004. Source of information from the National Weather Service website at www.nws.noaa.gov.
