COMMONWEALTH OF VIRGINIA
 DEPARTMENT OF MINES, MINERALS AND ENERGY
 DIVISION OF MINERAL RESOURCES

SELECTED SLOPE CATEGORIES AND KARST FEATURES MAP OF GILES COUNTY, VIRGINIA

1986

PUBLICATION 70
 SELECTED SLOPE CATEGORIES AND
 KARST FEATURES MAP
 OF GILES COUNTY, VIRGINIA

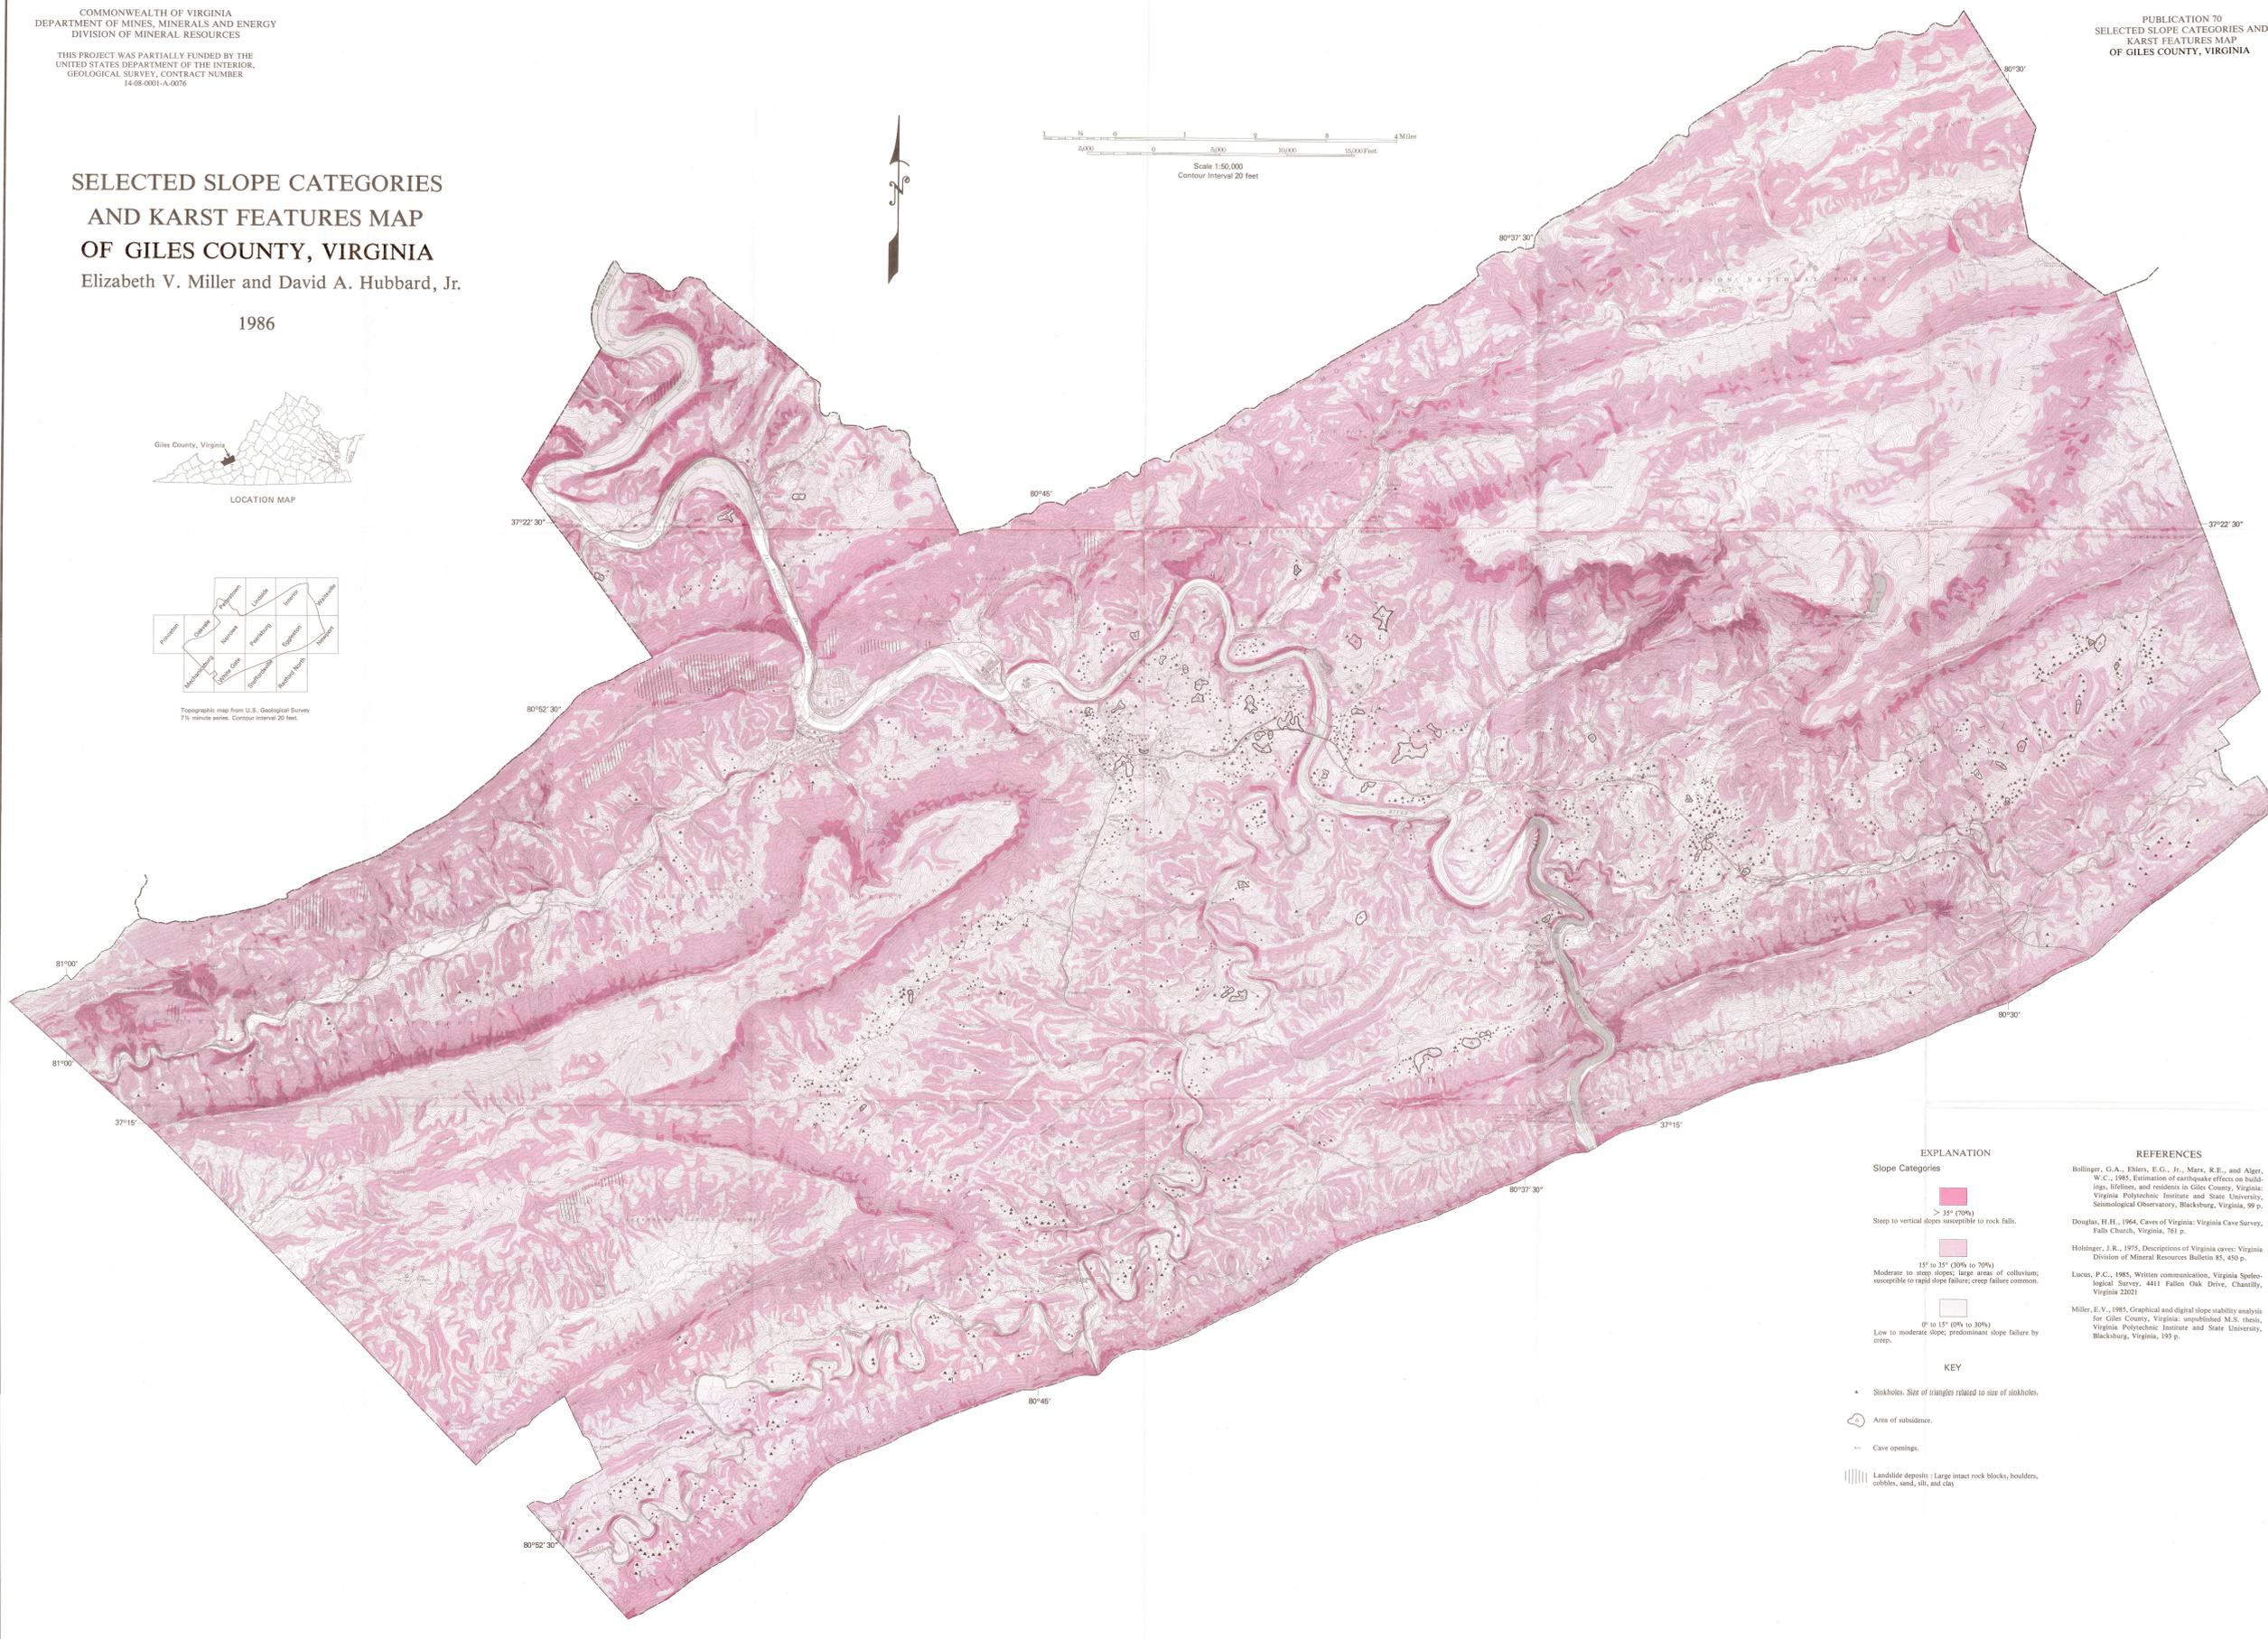
- > 35° (70%)
Steep to vertical slopes susceptible to rock fall.
- 15° to 35° (30% to 70%)
Moderate to steep slopes, large areas of colluvium, susceptible to rapid slope failure, creep failure common.
- 0° to 15° (0% to 30%)
Low to moderate slope, predominant slope failure by creep.

- ▲ Sinkholes. Size of triangles related to size of sinkholes.
- Area of subsidence.
- Cave openings.
- ||||| Landslide deposits: Large intact rock blocks, boulders, cobbles, sand, silt, and clay.
