HAZARD ALERT LIVE TOMORROW

REMOTE CONTROL MINER FATALITY

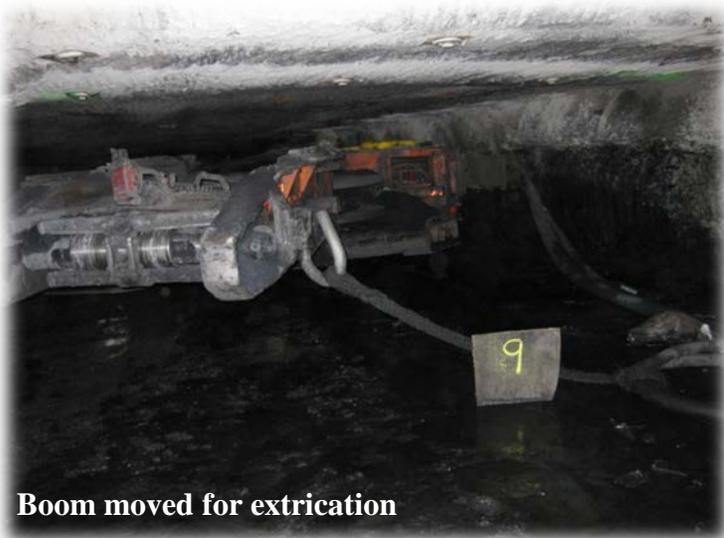
Boom moved for extrication

On Friday, February 21, 2014, at approximately 3:30 p.m., a continuous mining machine operator sustained fatal injuries when he was caught between the end of the conveyor boom and the coal rib. The victim was moving the continuous mining machine from the No. 2 entry to the No. 1 entry when the accident occurred. The victim was working alone and one of his coworkers found him entrapped between the continuous miner conveyor boom and the coal rib. The victim had approximately 5.5 years total mining experience and 3.5 years experience as a continuous miner operator. The mining height was approximately 44” where the accident occurred.

- Proximity Detection systems are available for installation on continuous mining machines.
- Training on “**RED ZONES**” should be conducted frequently for all mining personnel who operate or work near continuous mining machines.

- Mining machine operators should be stationed away from “**RED ZONES**” and in a safe location while tramming the machine from place to place or while repositioning in the area being mined.

- Low tram speed should be used when the left and right traction drives are operated independently (splitting the crawlers) while tramming or repositioning continuous mining machines.

- Another person should be immediately available to assist the continuous mining machine operator when the machine is being moved or repositioned.
- The “Right Choice”, a safety video developed by the Virginia Department of Mines, Minerals, and Energy, which addresses continuous mining machine operator safety, can be reviewed during various types of training and retraining classes.

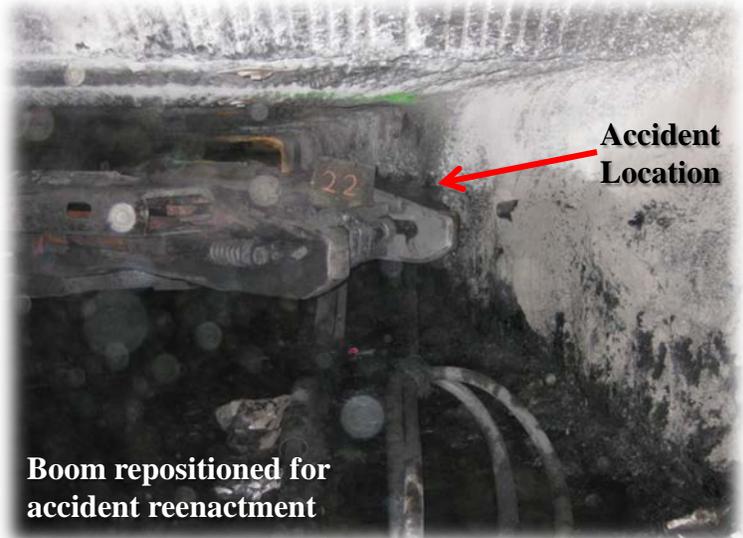
Boom repositioned for accident reenactment
