Division of Mineral Mining

Serious Injury Accident: Construction Worker Fall March 22, 2006

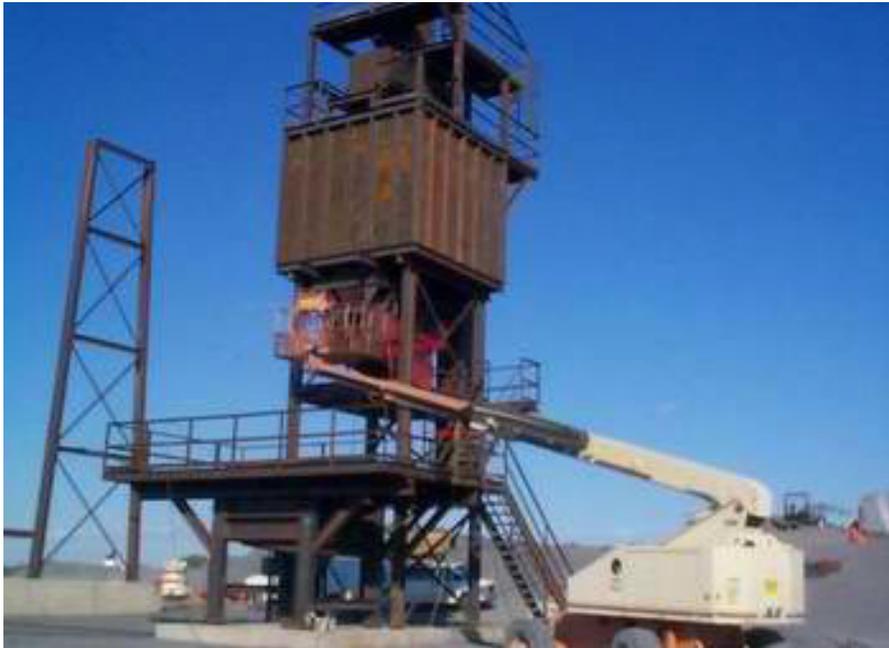
A contract welder was seriously injured when he fell from a surge bin feeder under construction at a mine site. The injured worker was climbing a portable ladder when it slipped causing him to fall approximately 12 feet to the crusher platform below. The ladder was positioned unsupported within the surge bin to provide access to welding positions. Once in position, the welders would tie-off their safety harness lanyards. As the victim neared the top of the ladder, the ladder feet slipped causing the ladder and victim to fall through the feeder discharge chute. The victim suffered multiple fractures to his right ankle and ribs.

The surge bin feeder structure where the accident occurred. The man-lift basket was positioned to stabilize feeder and block opening of feeder chute.

CONCLUSIONS/RECOMMENDATIONS: This accident occurred due to unsafe working conditions and unsafe work practices. The construction contractor failed to provide the welder safe access into the surge bin structure, and the injured welder should not have climbed the unsecured portable ladder. Prior to assigning work assignments, the certified mine foreman or "competent person", as applicable, should ensure that workers are provided safe access to all work areas. Periodically during a shift, the certified mine foreman or "competent person" should check workers to ensure safe working conditions and safe work practices.

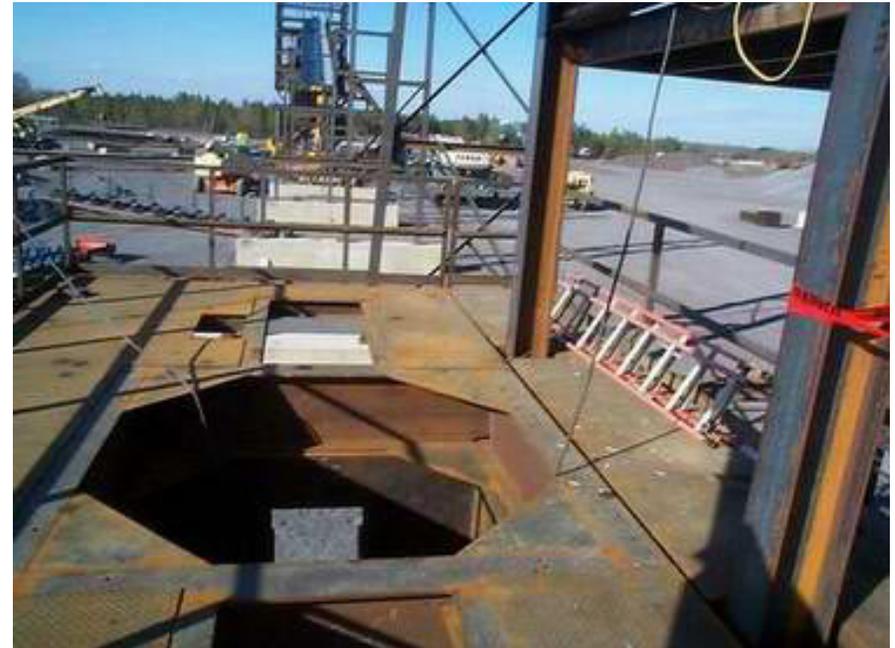
The injured worker landed on this metal platform next to the unguarded opening shown in the center of this photograph.
